# INSPECTION DEPARTMENT

Brochure

# The Department

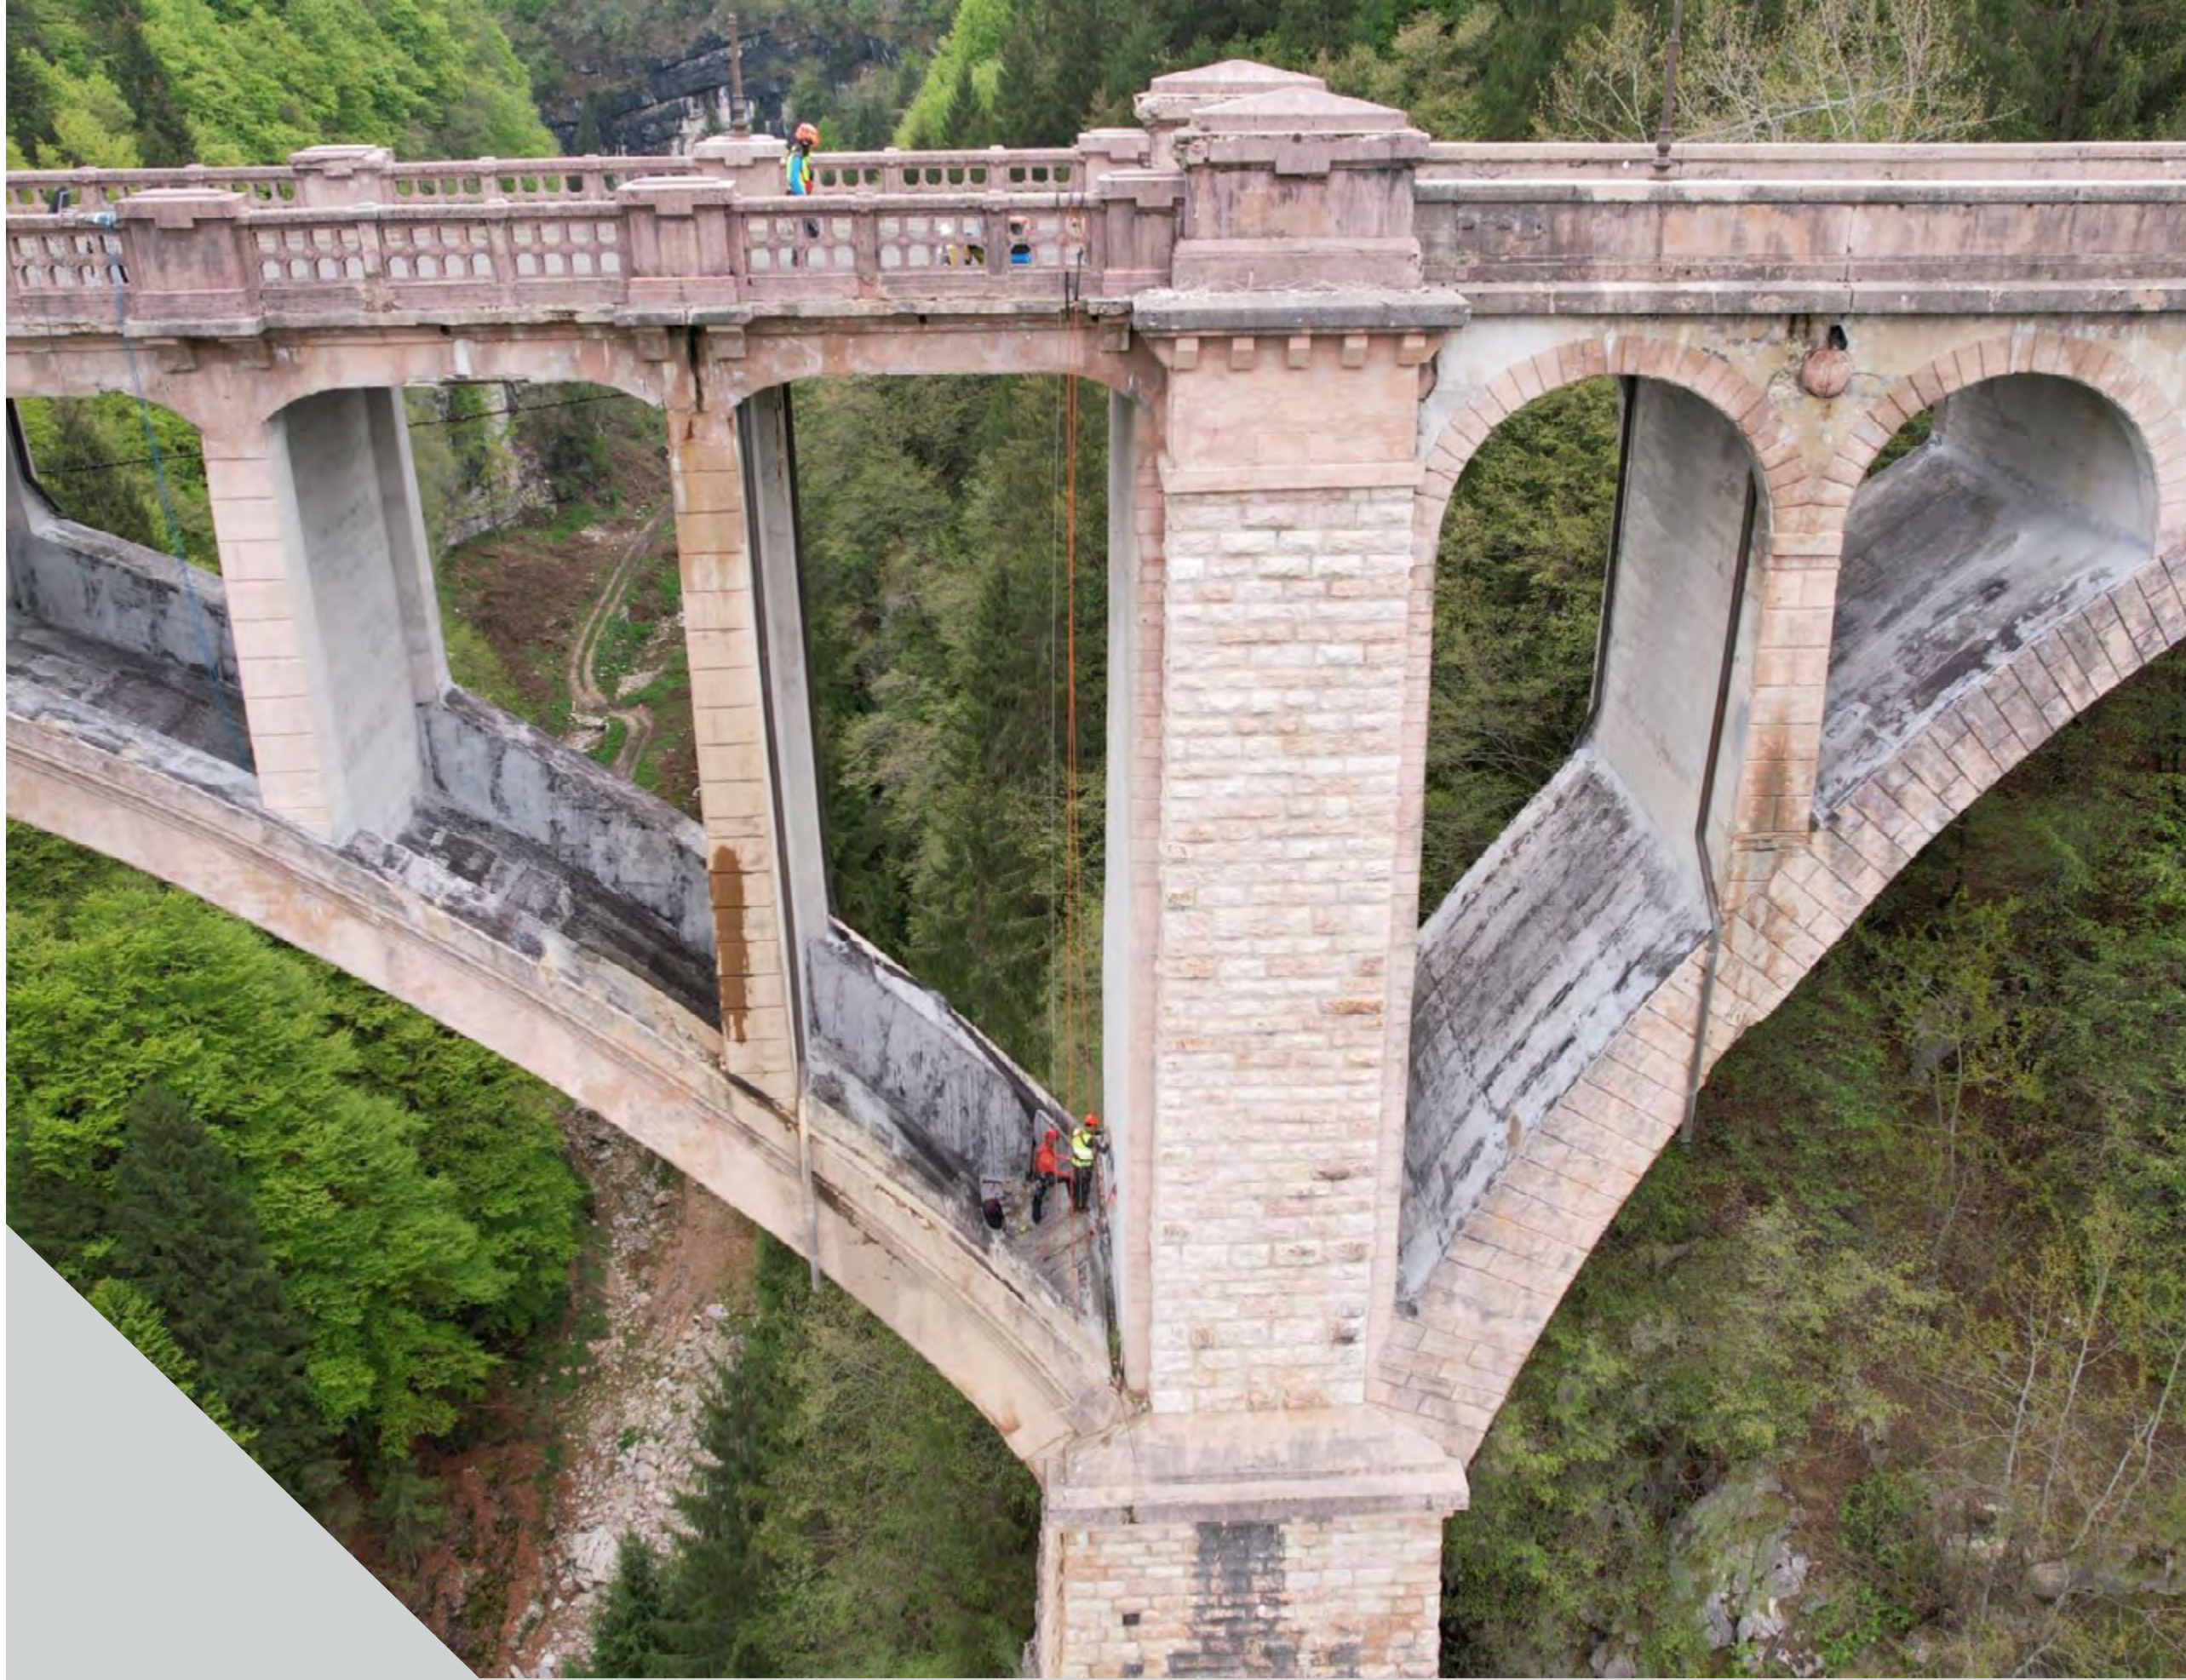
# Roana Bridge

Service for performing structural tests at height, carried out by rope climbers on the Granatieri Bridge in Roana

The first group is designed to investigate, detect or verify the number of the present longitudinal and transverse irons, the height of the iron cover and the geometric dimensions of the structural elements; the second group is to investigate the resistance characteristics of the materials such as removal of concrete cores and reinforcing bars, SonReb and hardness tests.

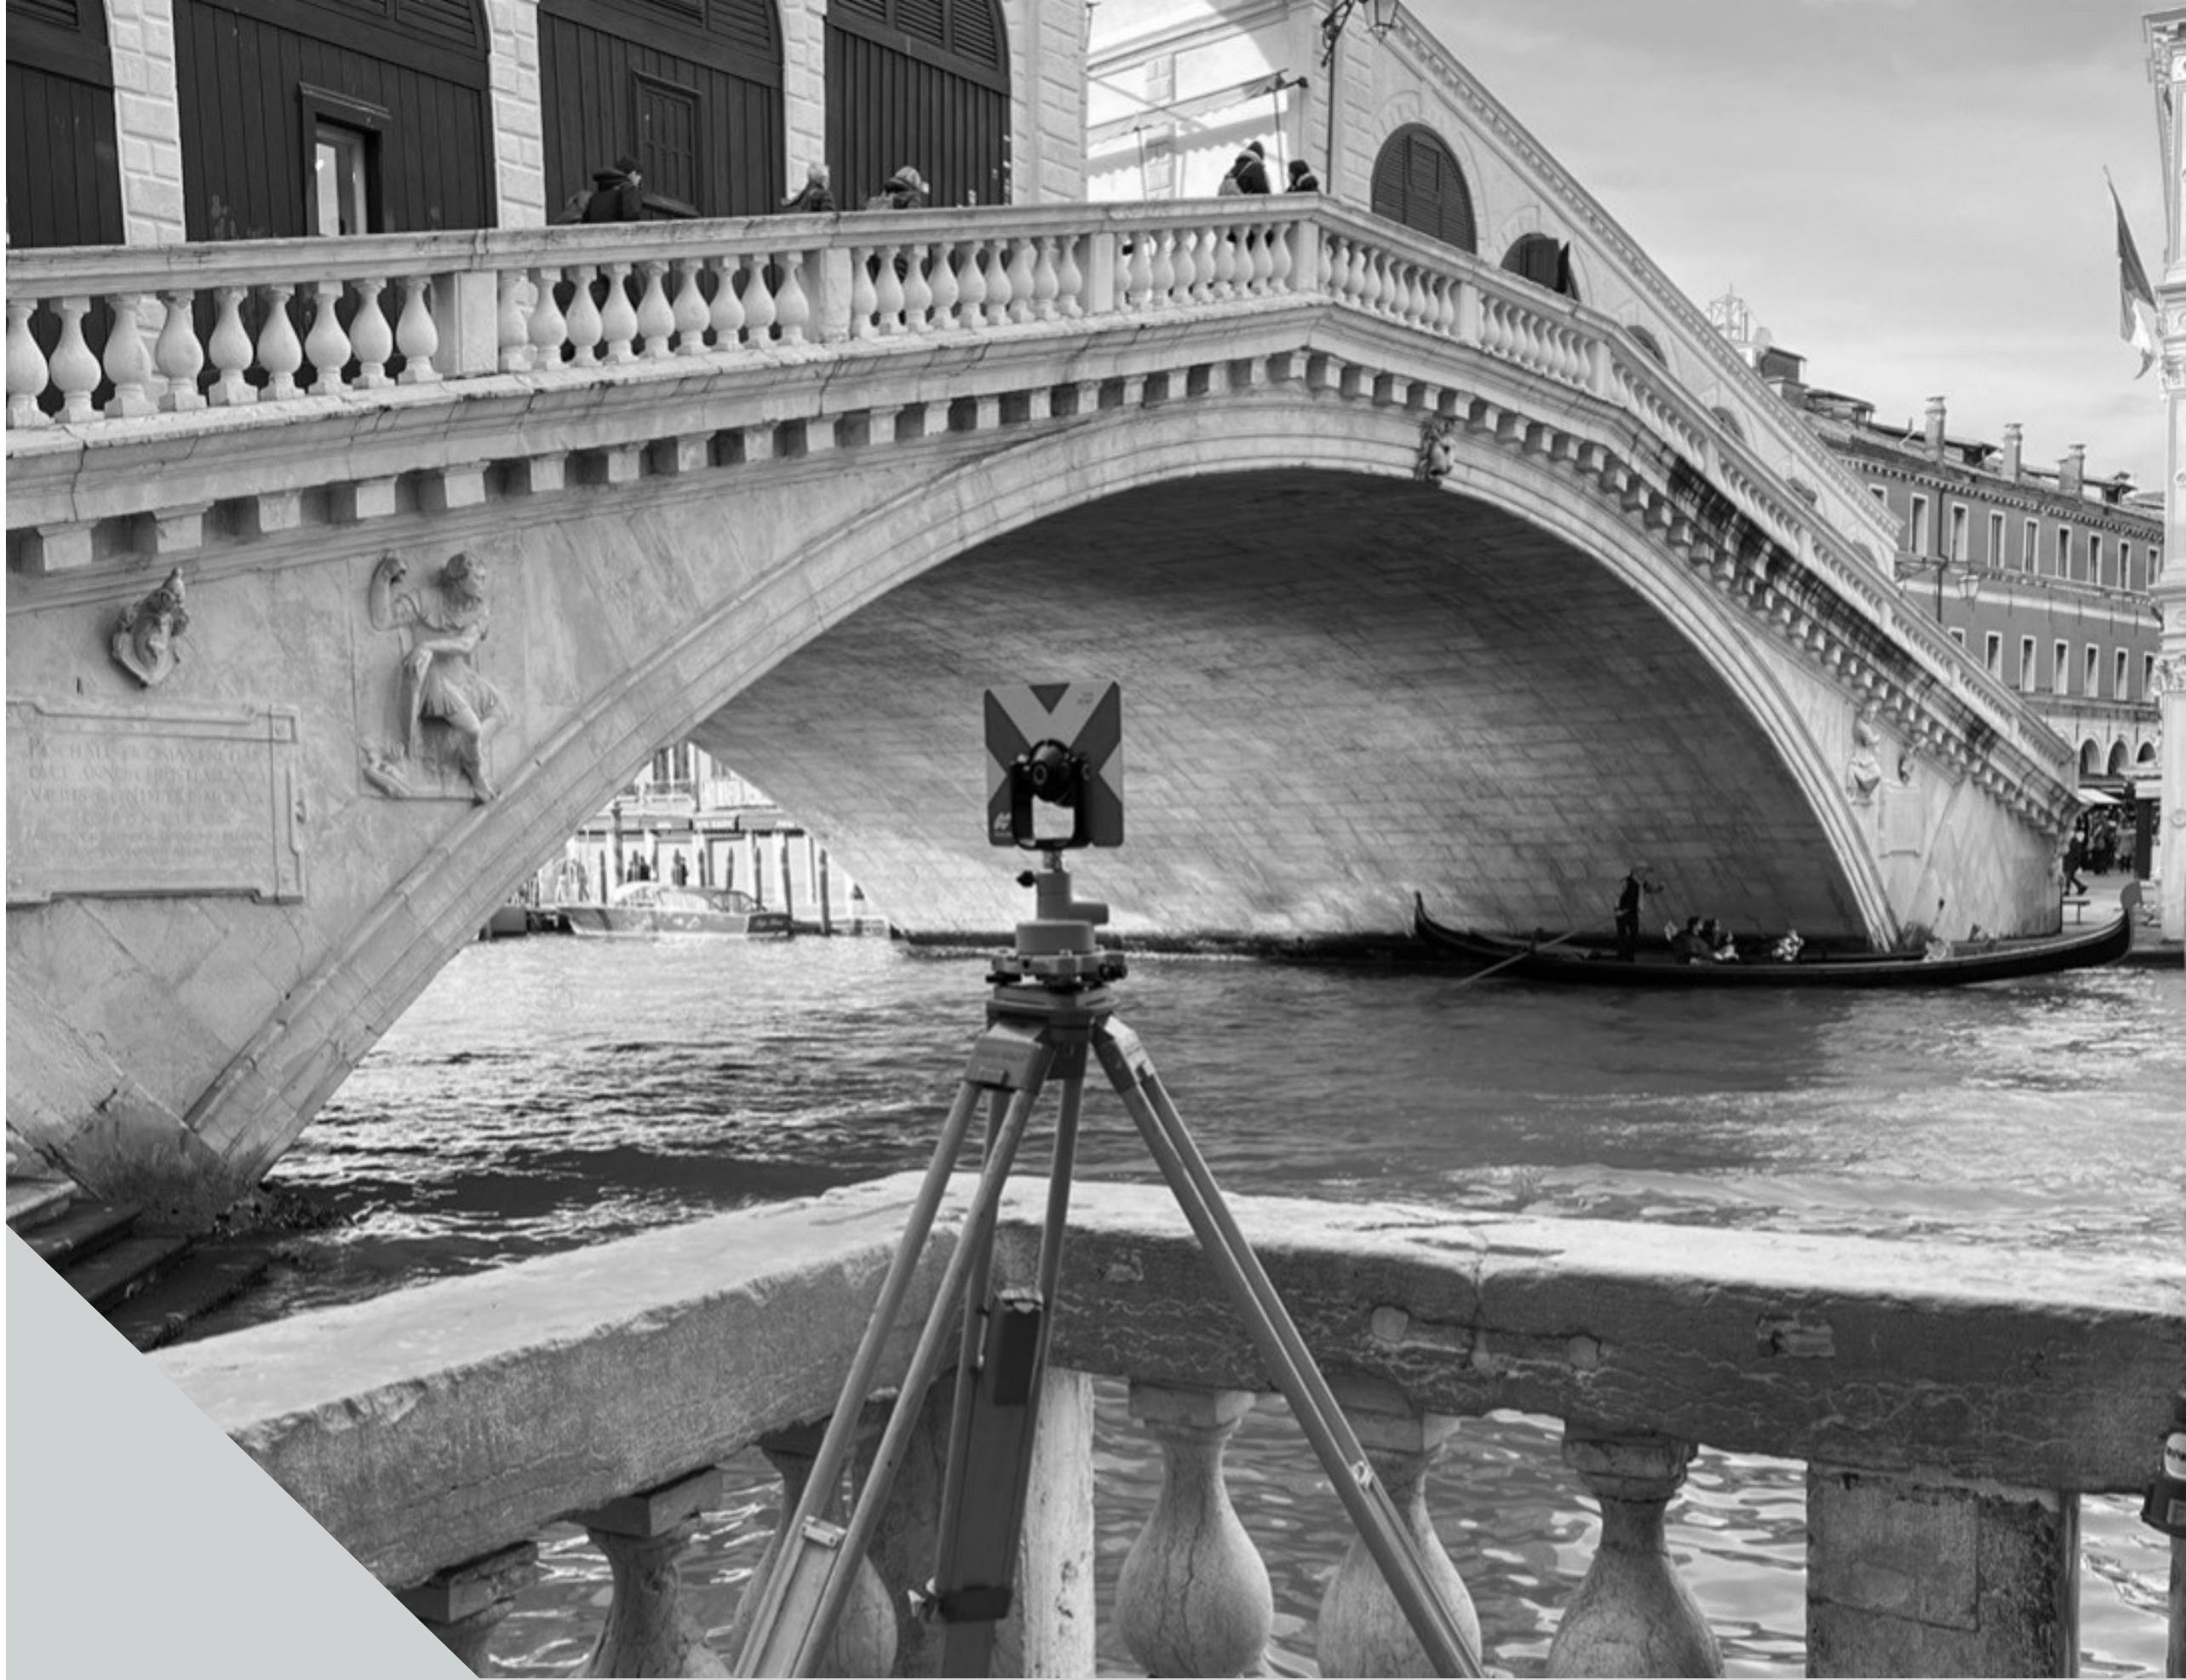
# Rialto Bridge

In the initial phase, all structures were geolocated and catalogued through topographic and photogrammetric surveys, with the generation of custom point clouds using drone technology. This phase was essential for the proper compilation of Level 0 inventory sheets in accordance with MIT (Italian Ministry of Infrastructure and Transport) guidelines. The data collection was complemented by a thorough historical, landscape, hydraulic, and geological documentation review for each structure.

In the following phase, certified Level 2 and Level 3 inspectors were deployed on site to complete the Level 1 defect sheets. Using drones and rope-access techniques, they were able to closely inspect every part of the structures.

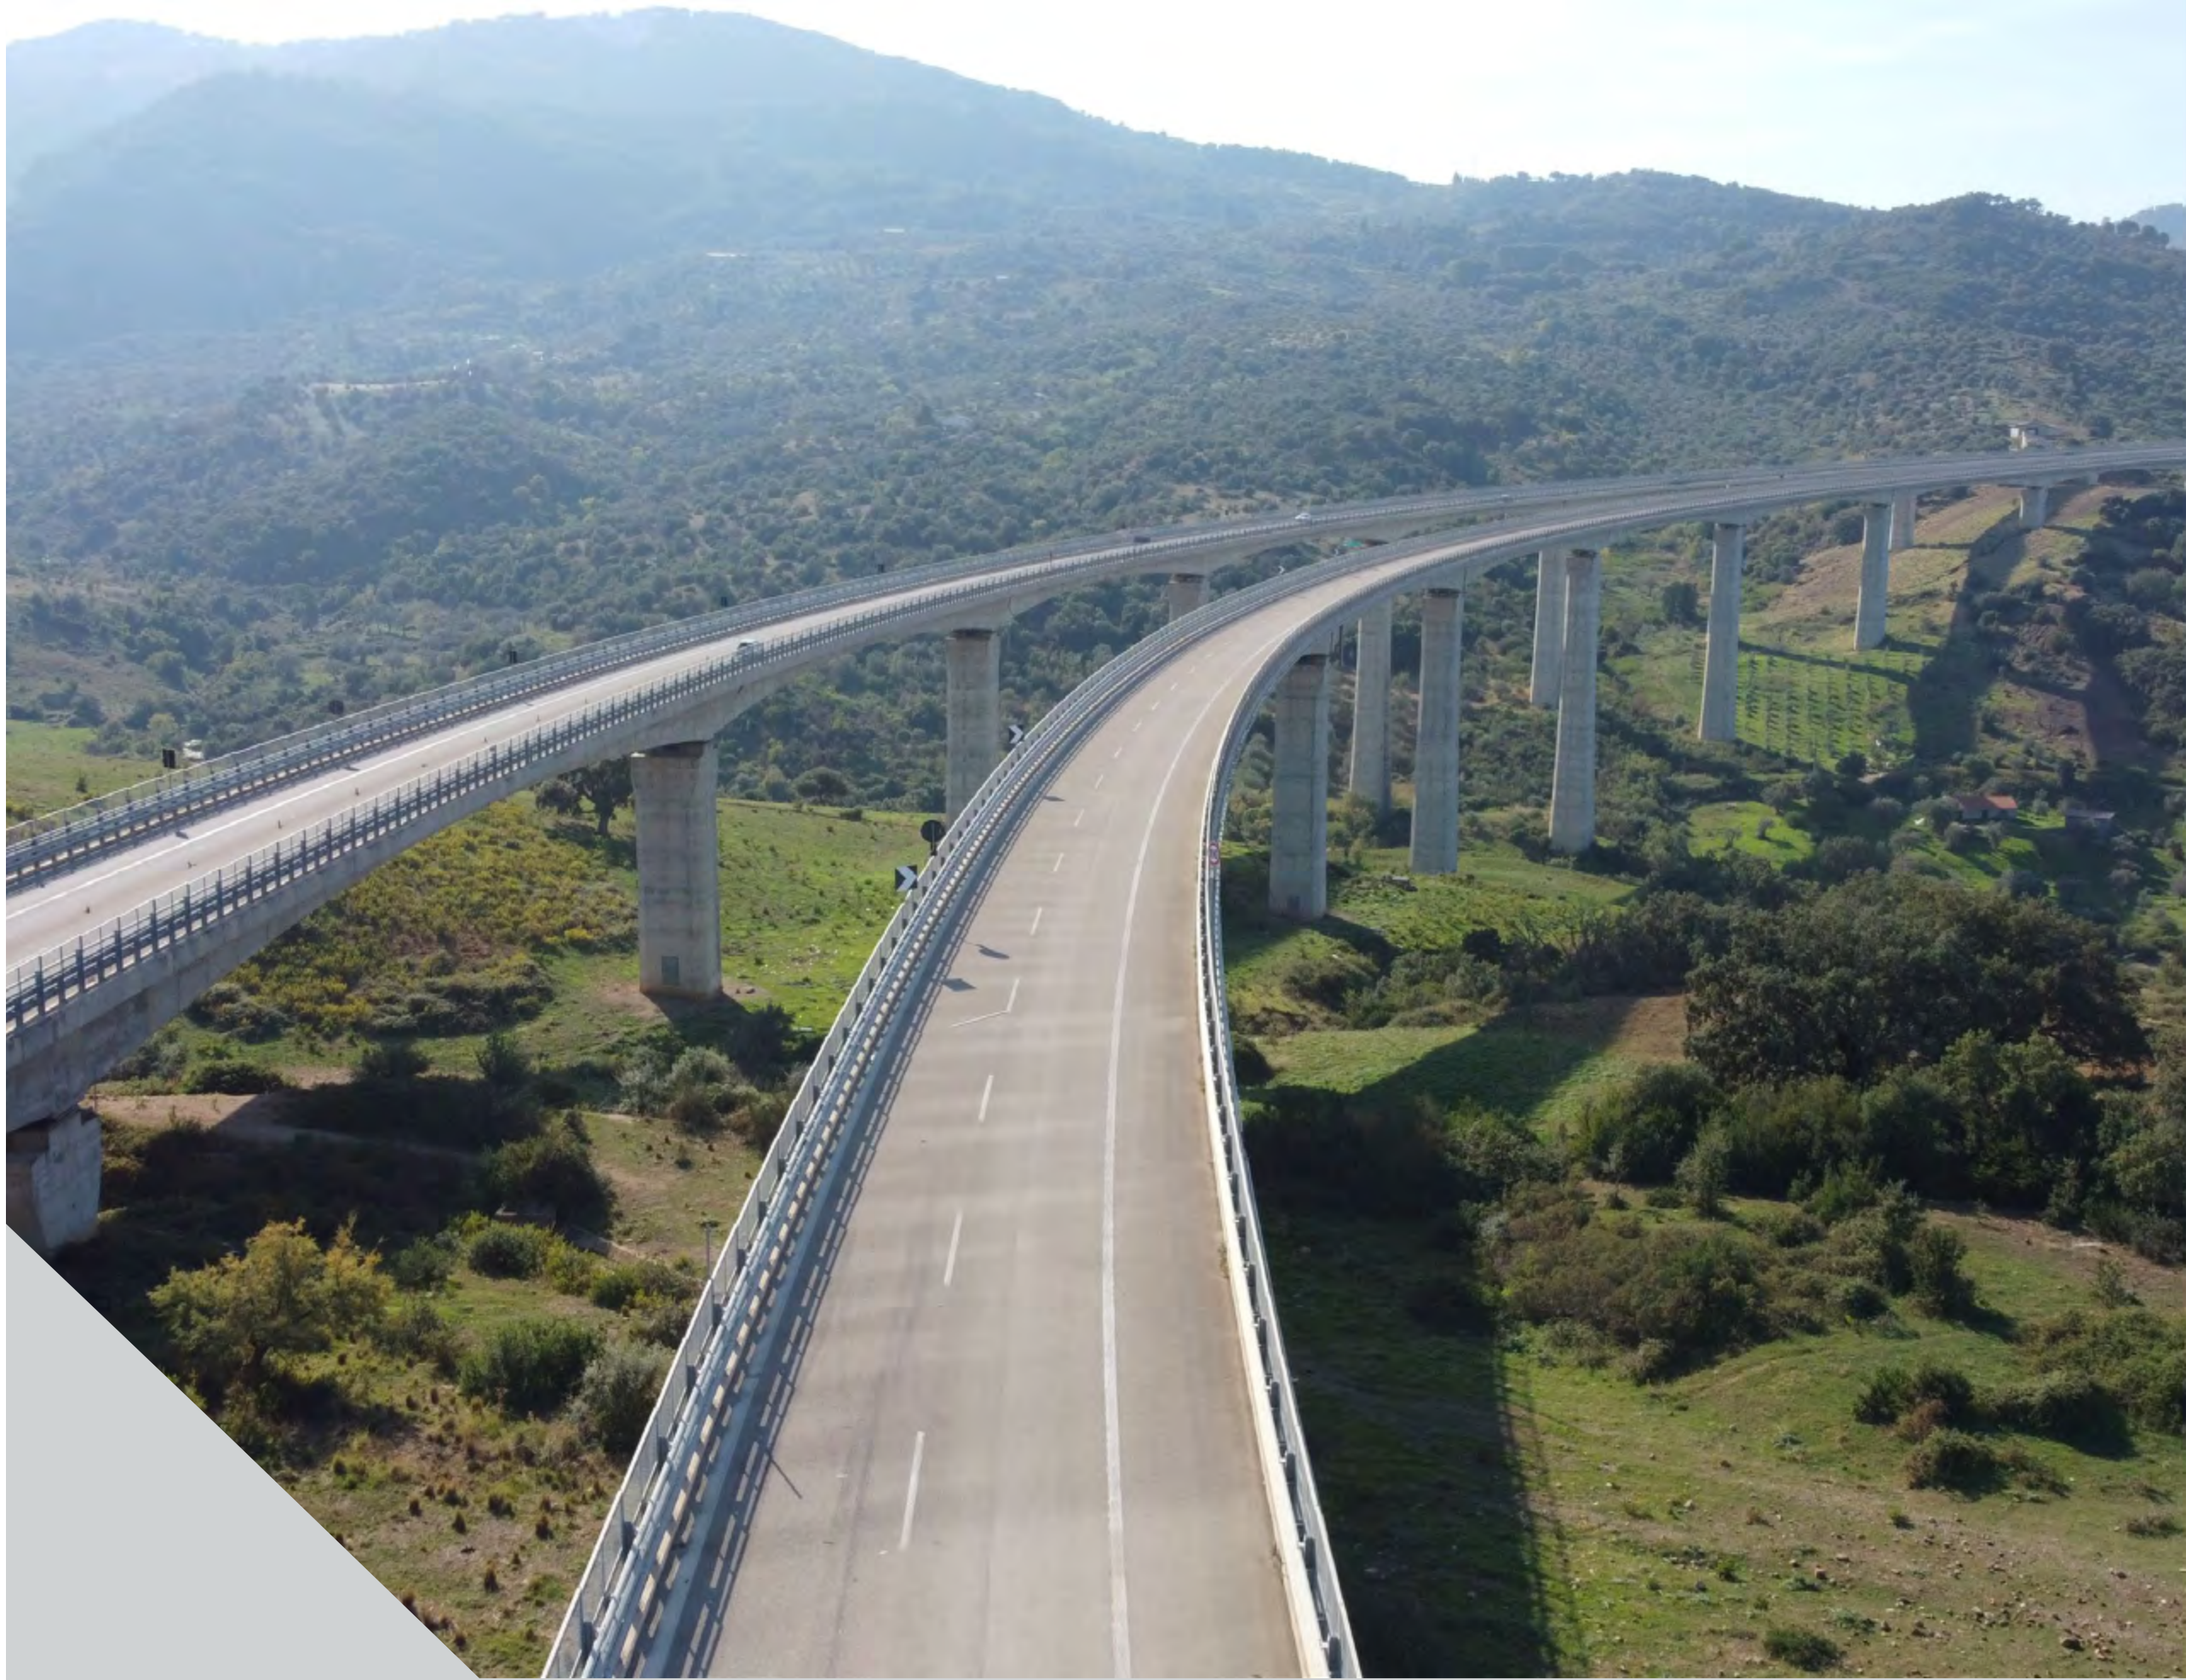
# Messina–Palermo Highway

Census, primary visual inspections, and determination of the state of conservation of bridges and viaducts on the Messina-Palermo Highway

In the initial phase all the works were geolocated and recorded using topographic and photo-gram surveys with the return of ad hoc point clouds thanks also to the use of drones. This phase, along with a historical, landscape, hydraulic, and geological document research for each individual structure, was important for compiling Level 0 census sheets following MIT guidelines. The next phase involved the Level 2 and 3 inspectors in the field, for the compilation of the Level 1 defect sheets, who through the use of drones and mountaineering techniques were able to inspect and closely view every part of the work in question.

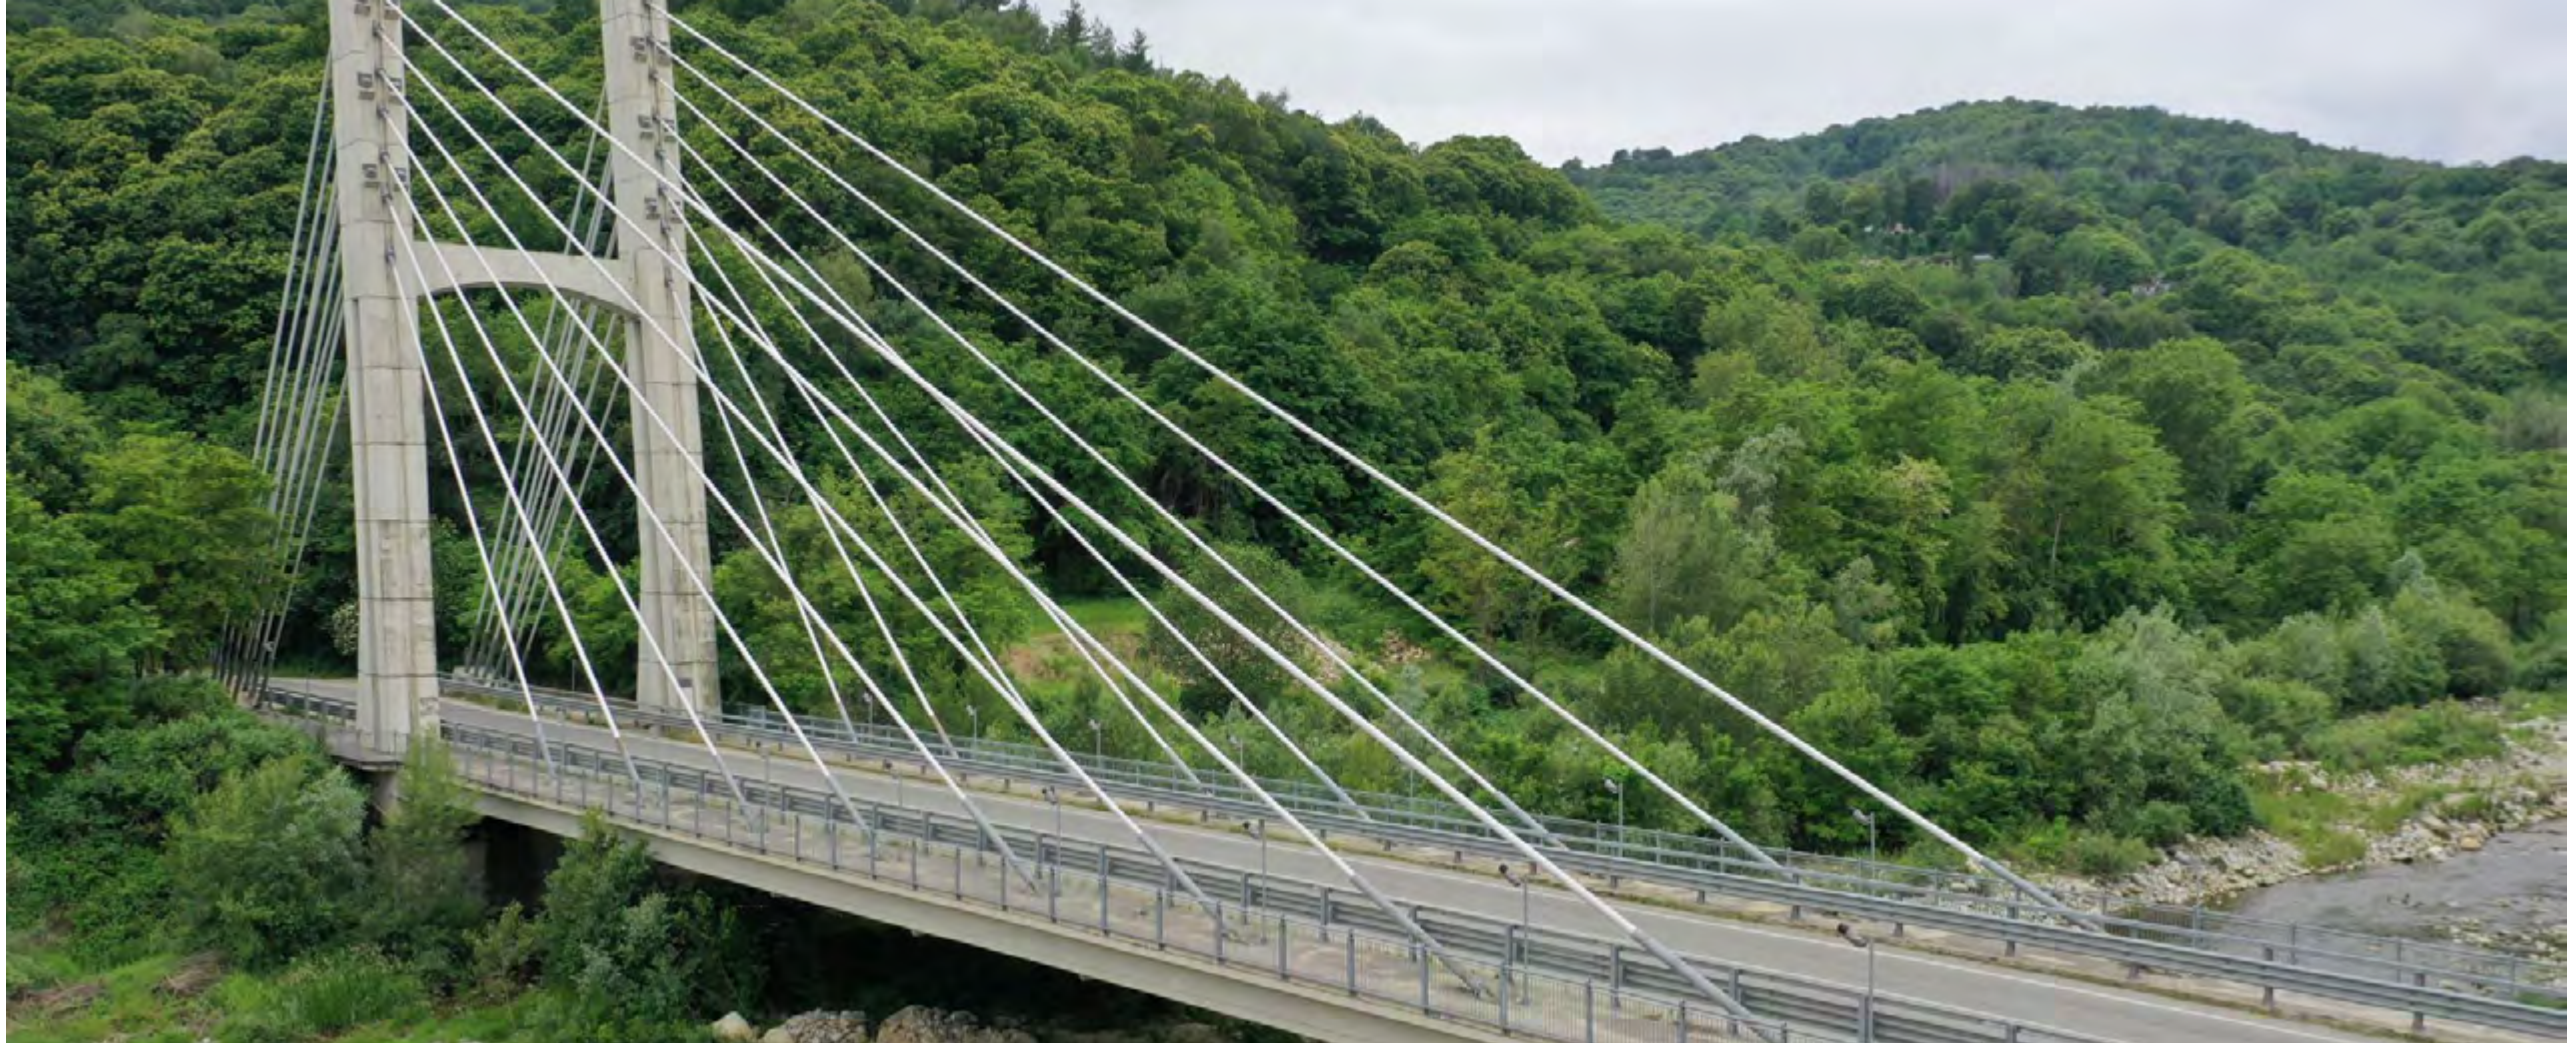
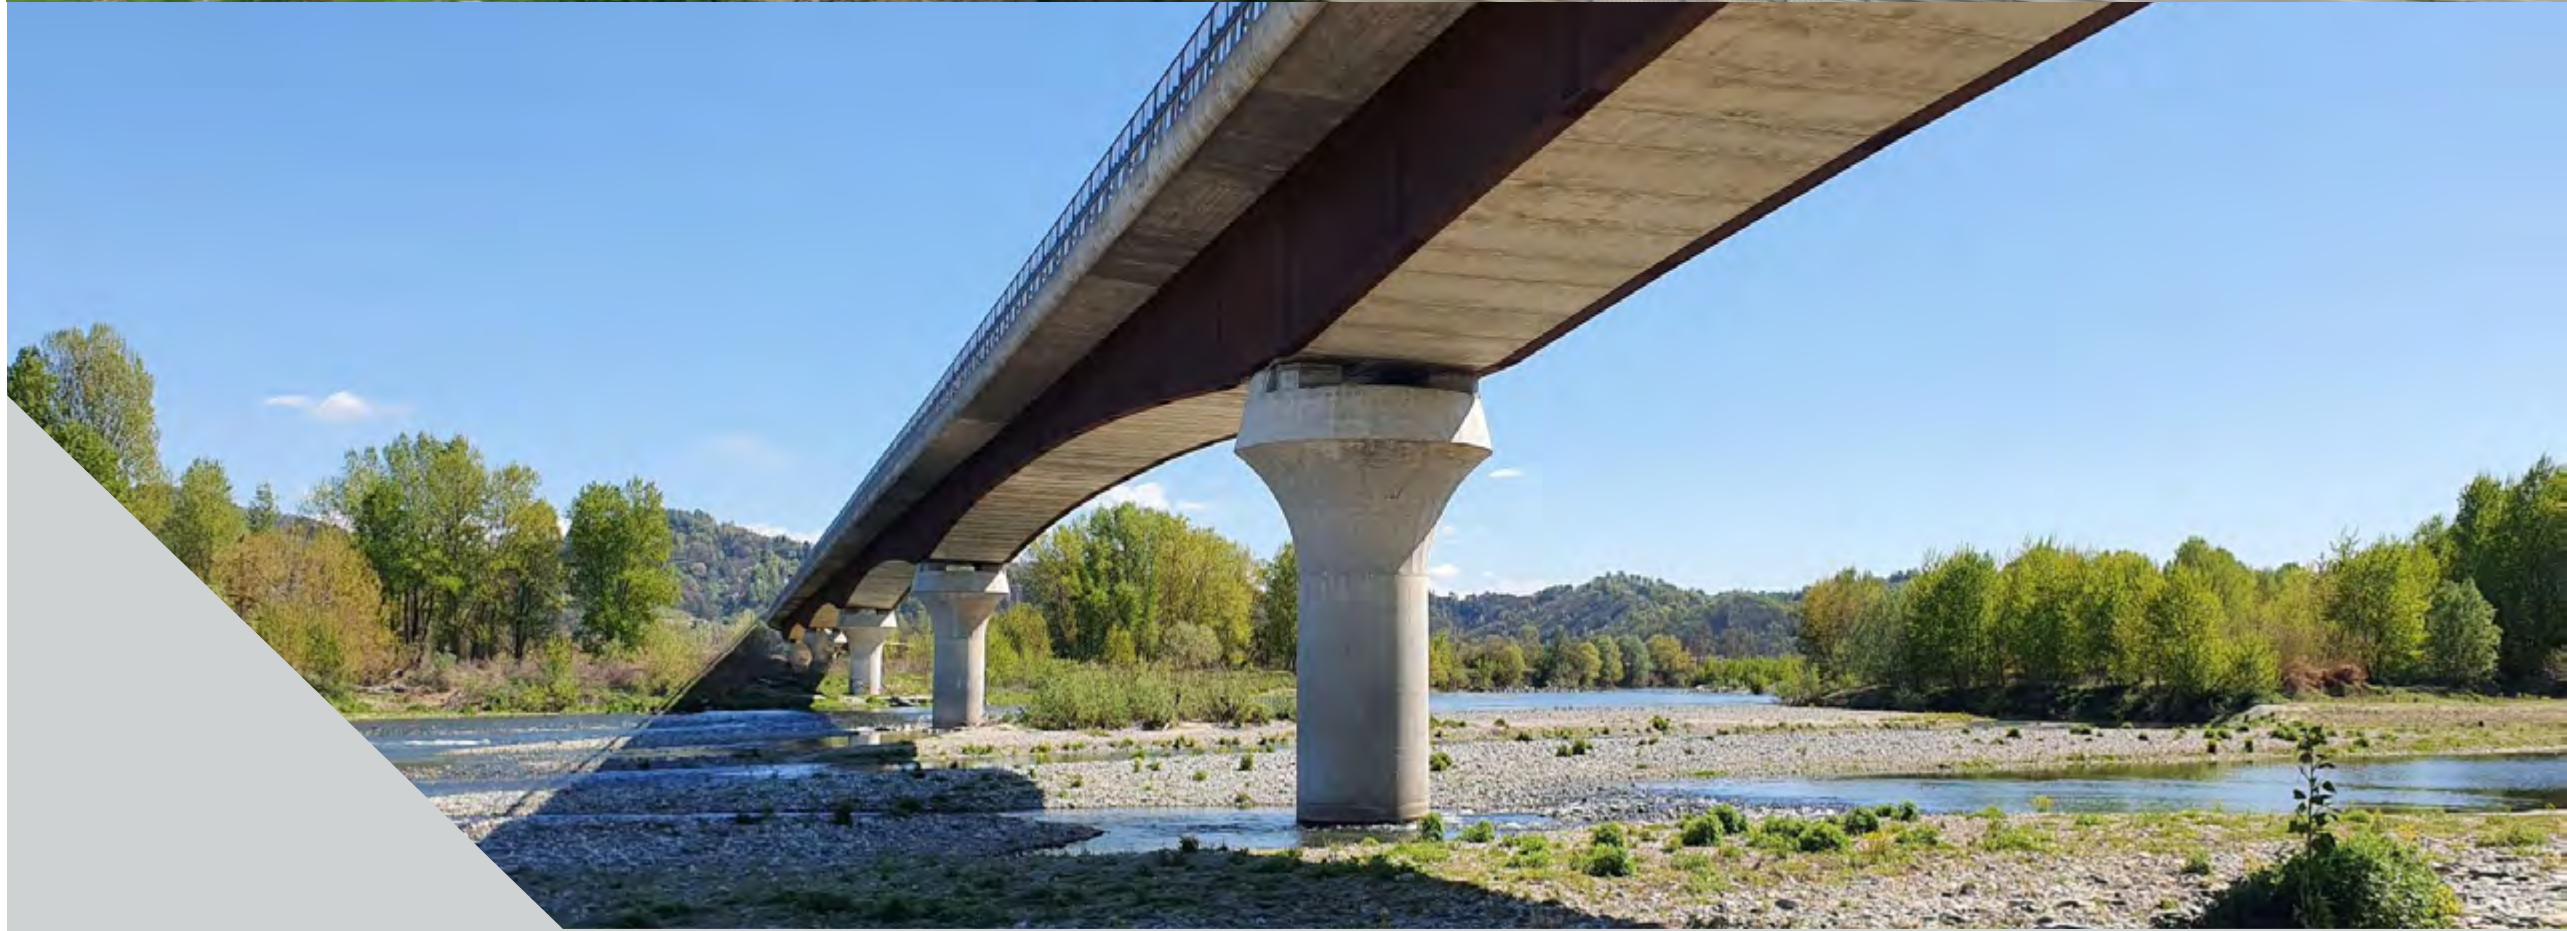
# Giaveno and Gassino Bridges

Multilevel analysis: documentary research, inspections, investigation plan, support investigations, report on the state of the structure, and maintenance plan update

The interventions were based on a multilevel approach following the guidelines of the Ministry of Infrastructure and Transport. For each structure, historical document research, Level 0 census, Level 1 visual inspection conducted by engineers from the Inspection team qualified as Level 2 and 3 bridge and walkway inspectors, the use of mobile APRs (Drones) even in critical areas to reach less accessible areas, and expertise in reaching confined spaces, such as the interior of decks assembled for post-tensioned cable concretes. Subsequently, a plan for special investigations was developed to obtain a correct assessment of the defectiveness of post-tensioned pre-compression cables, in the case of the Gassino Bridge, and of the heads of the stays and the antenna, in the Giaveno Bridge, to reach Level 4 as required by regulations in the case of post-tensioned structures. Finally, operational direction in situ investigations was provided, with preparation of the report on the state of the work in accordance with guidelines and updating the plan of maintenance for the two works.

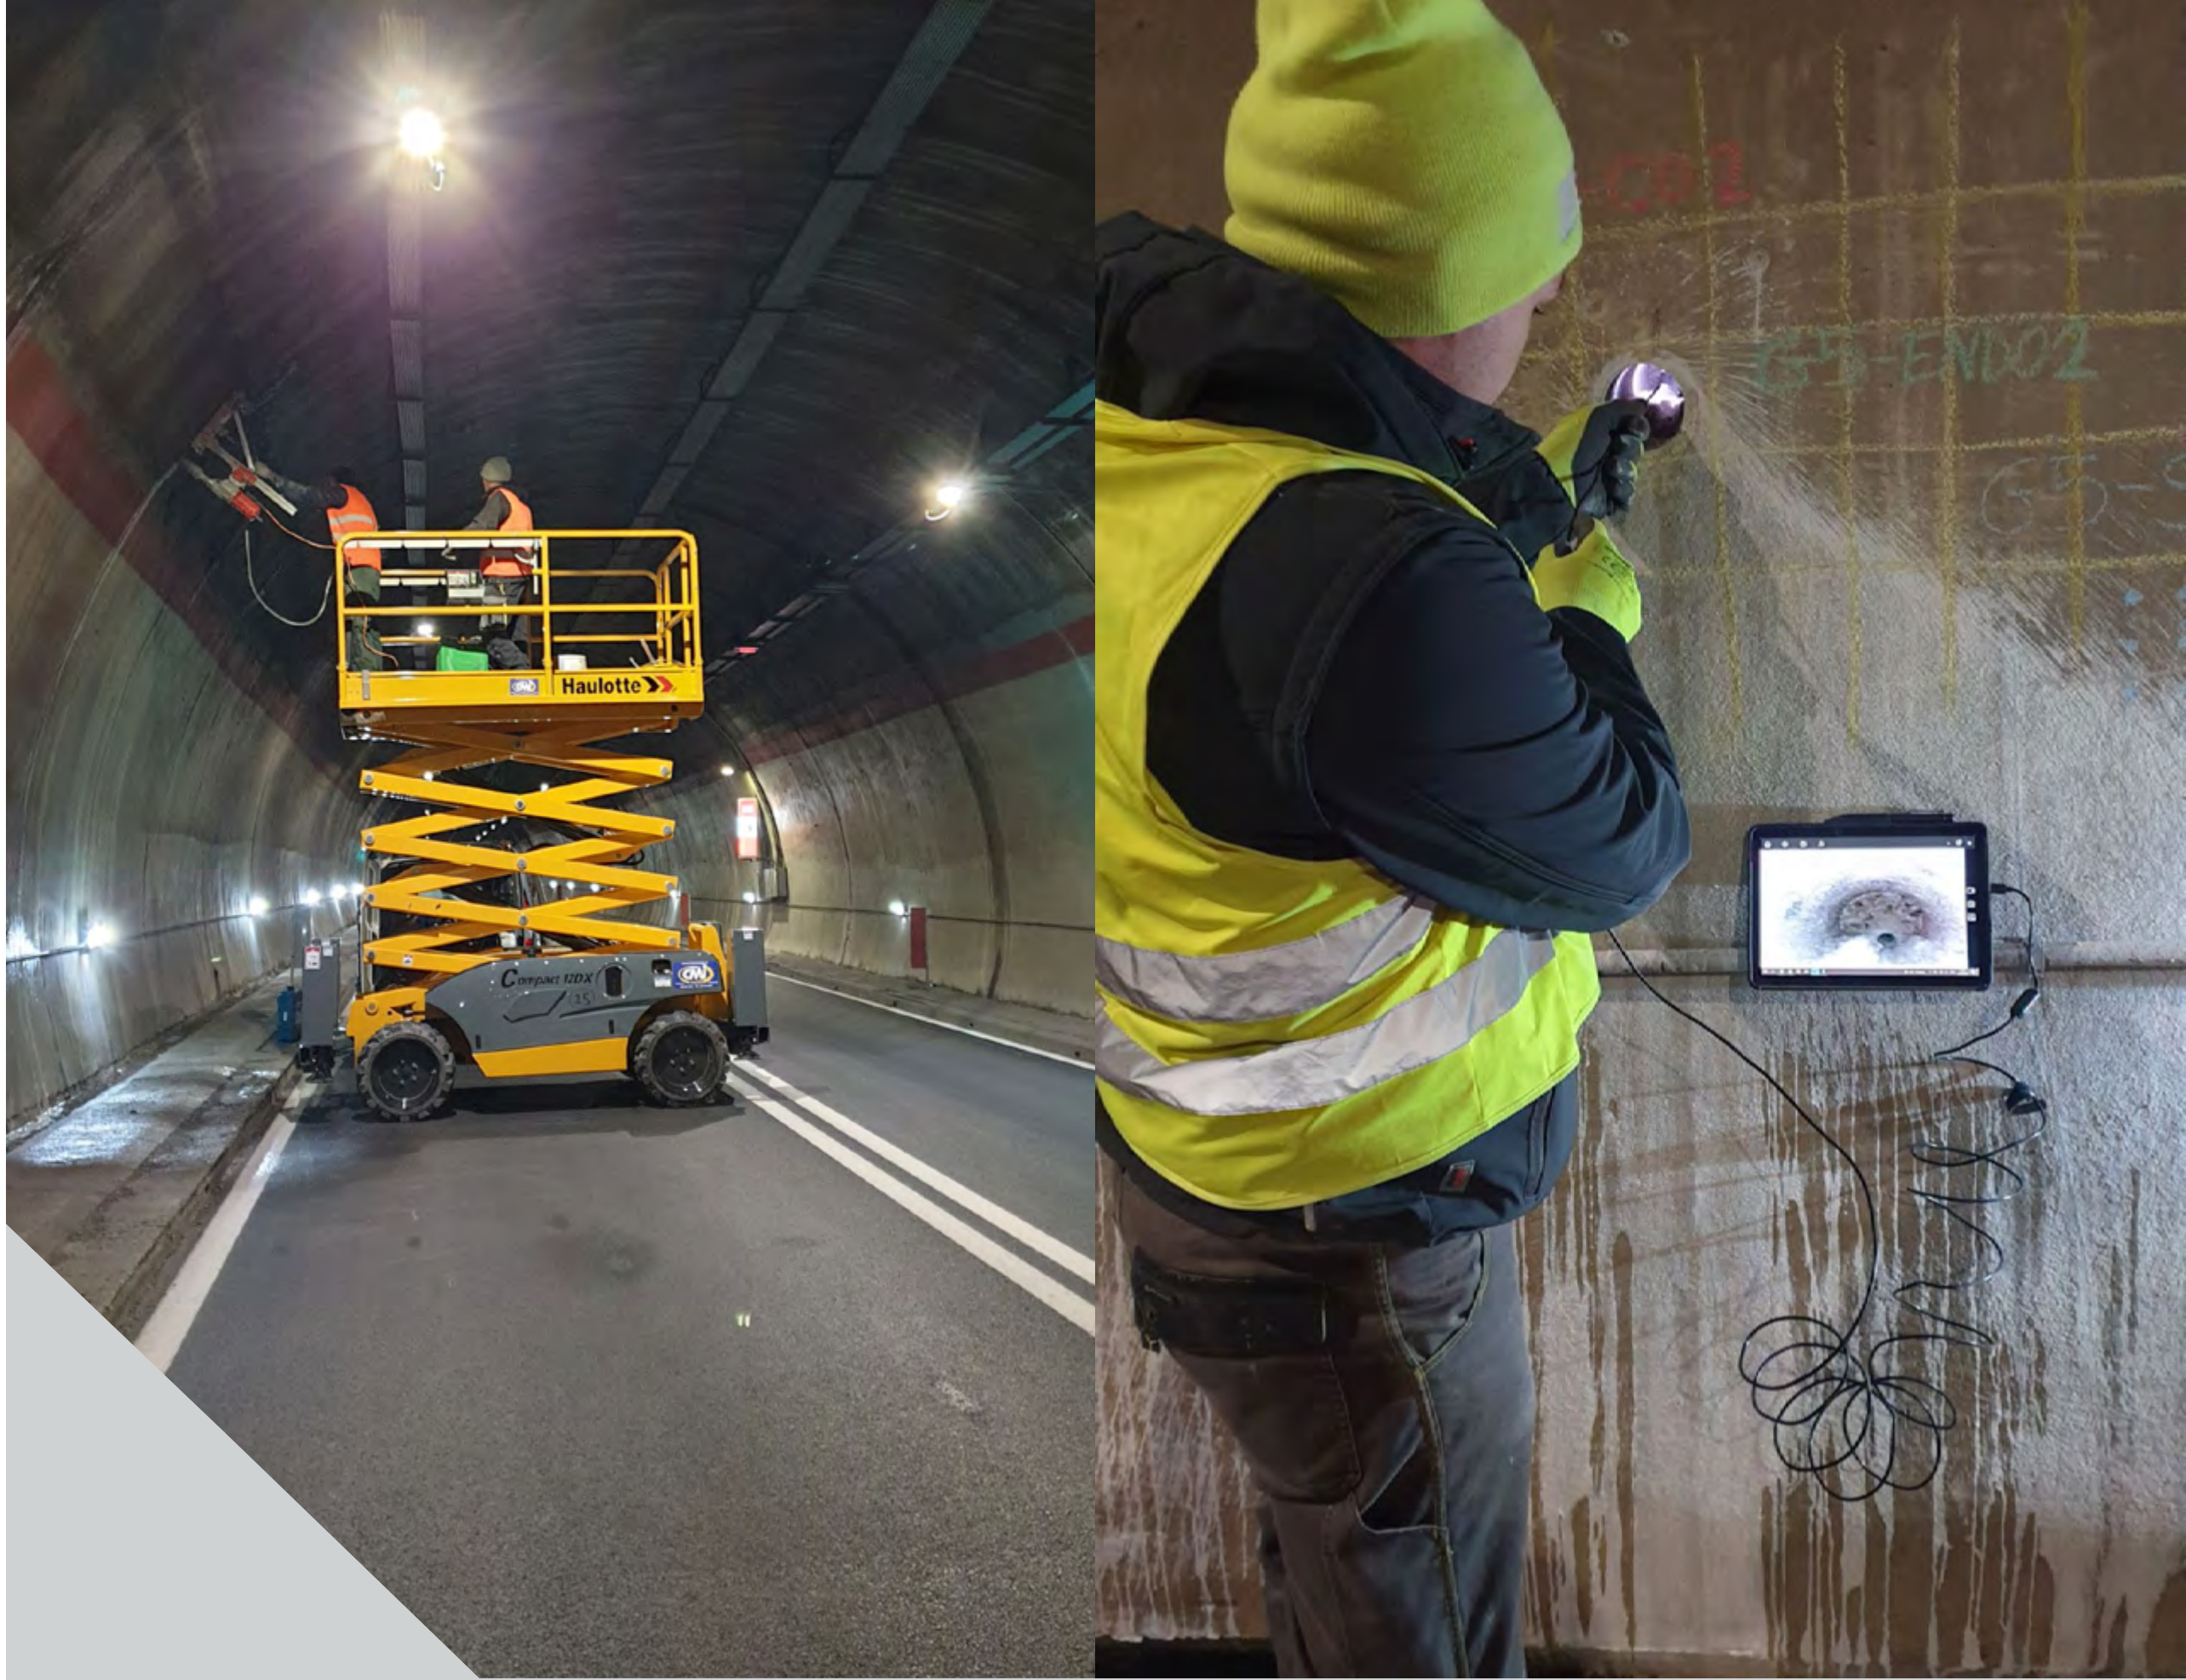
# ANAS Framework Agreement - Tunnels Inspections

## Main and in-depth inspections of tunnels of the Veneto Region Network Management Area

The intervention carried out concerns the visual and in-depth inspections of some tunnels on the ANAS roads of the Veneto Region. In particular, a first phase of geolocation of the works subject to inspection has been planned with the night closures of the tunnel to reduce as much as possible the inconvenience to normal road life (this service was also performed by ITS technicians by virtue of the technical employees trained and licensed to perform such road maneuvers). A subsequent phase involved the field of inspection according to ANAS internal guidelines and complying with MIT LL.GG, including visual inspection and a series of tests of both topographic and structural survey with: georadar tests, pacometric tests, ultrasonic tests, sclerometric tests, sonreb tests, concrete core samples, survey and depth of detected cracks, microcarots with videoendoscopies. In the final phase, a report was prepared including all of tests and services performed, along with a series of graphical drawings suitable for obtaining an objective view of the inspection that took place and to laboratory certificates of the tests performed.
