# INSPECTION DEPARTMENT

Brochure

# The Department

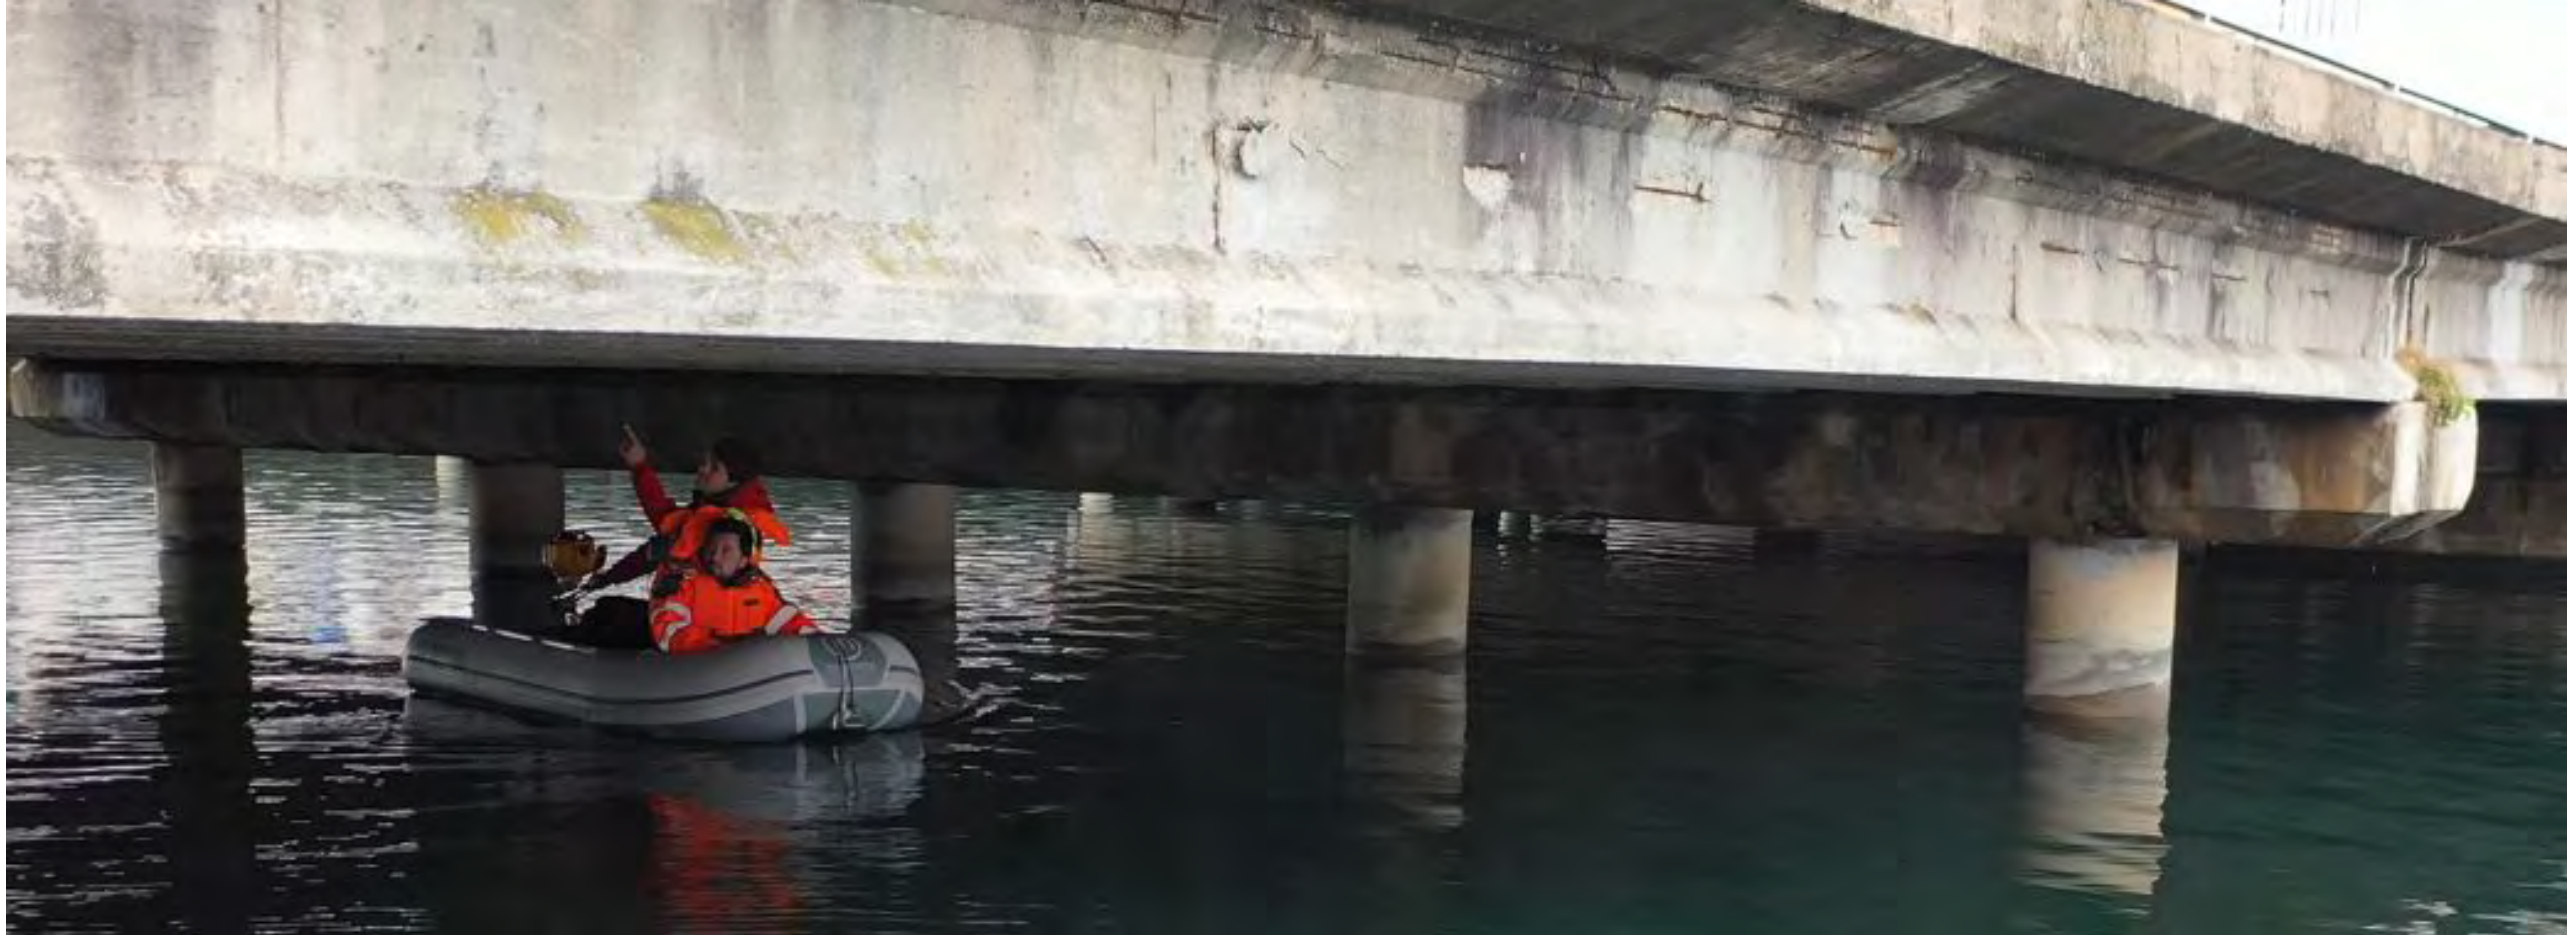
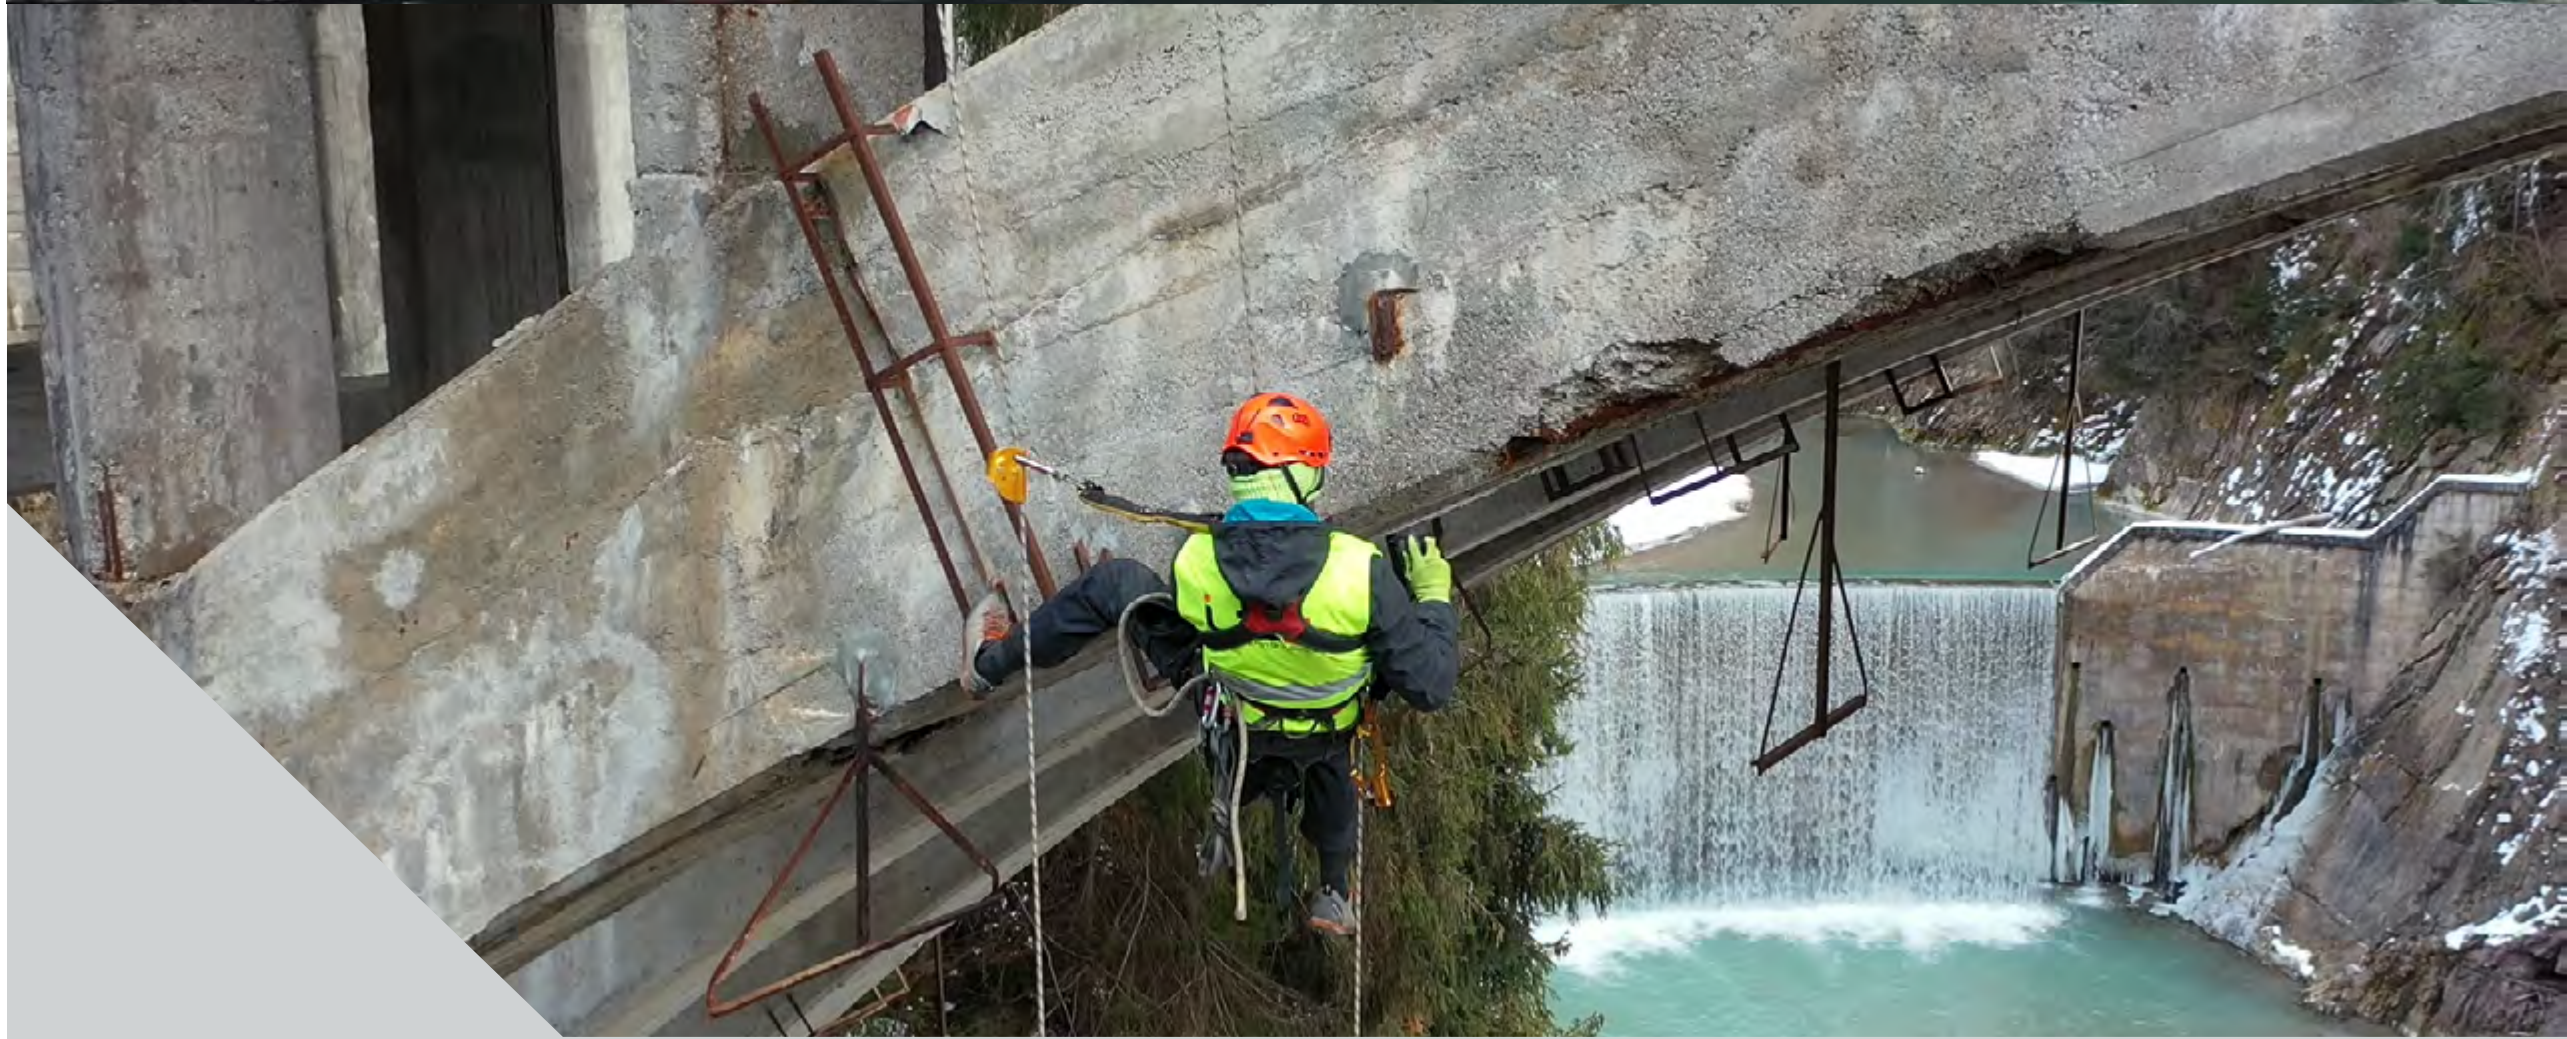
# ANAS Framework Agreement - Bridges Inspections

Main inspection services of bridges, viaducts and tunnels within the ANAS Territorial Structures in Lombardy, Friuli Venezia Giulia and Veneto Regions

The intervention involves visual and in-depth inspections of some tunnels on ANAS roads in the Veneto Region. Specifically in the first phase, all the interventions were located in order to catalog all possible problems. The inspection phase was carried out with the support of a digital camera and an Ipad equipped with a BMS (Bridge Management System) application. The subsequent phase involved on-site inspection following ANAS internal guidelines and compliance with the regulations of the Ministry of Infrastructure and Transport (MIT). In the post processing, the return of the inspections was processed by preparing a report detailed for each individual element of the inspected works with the defects found and their cause of origin. For completeness, plans and sections were attached schematic of the works, showing the optical cones representing the points of taking photos, and the defects at the point where they were detected on the work. Based on the findings of the visual inspections and in particular in order to further investigate possible critical issues, some investigations were sub-sequently proposed and carried out structural targeted, to assess in a concrete way and with direct feedback, the actual state of degradation of some structural elements of the selected works.

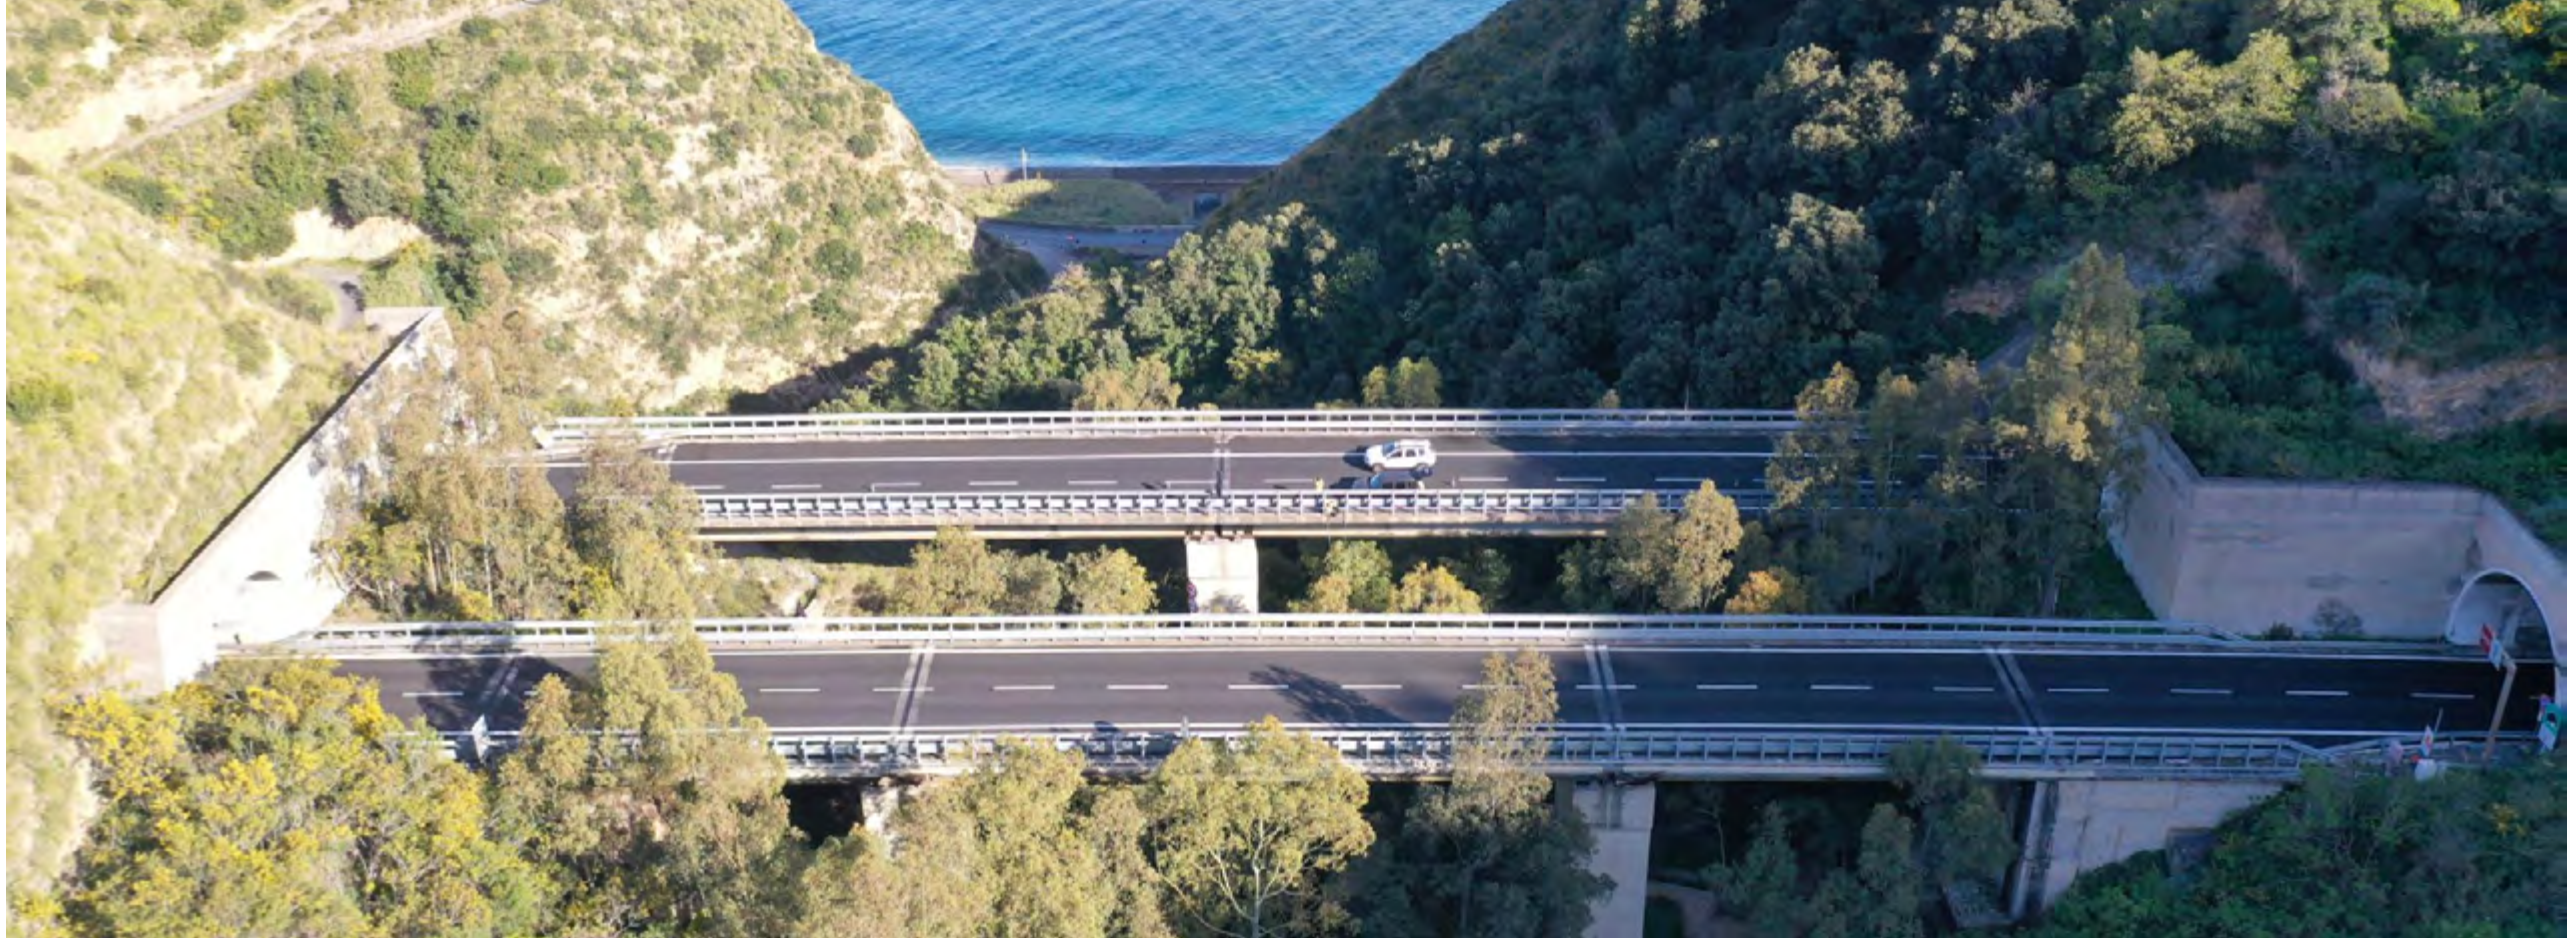
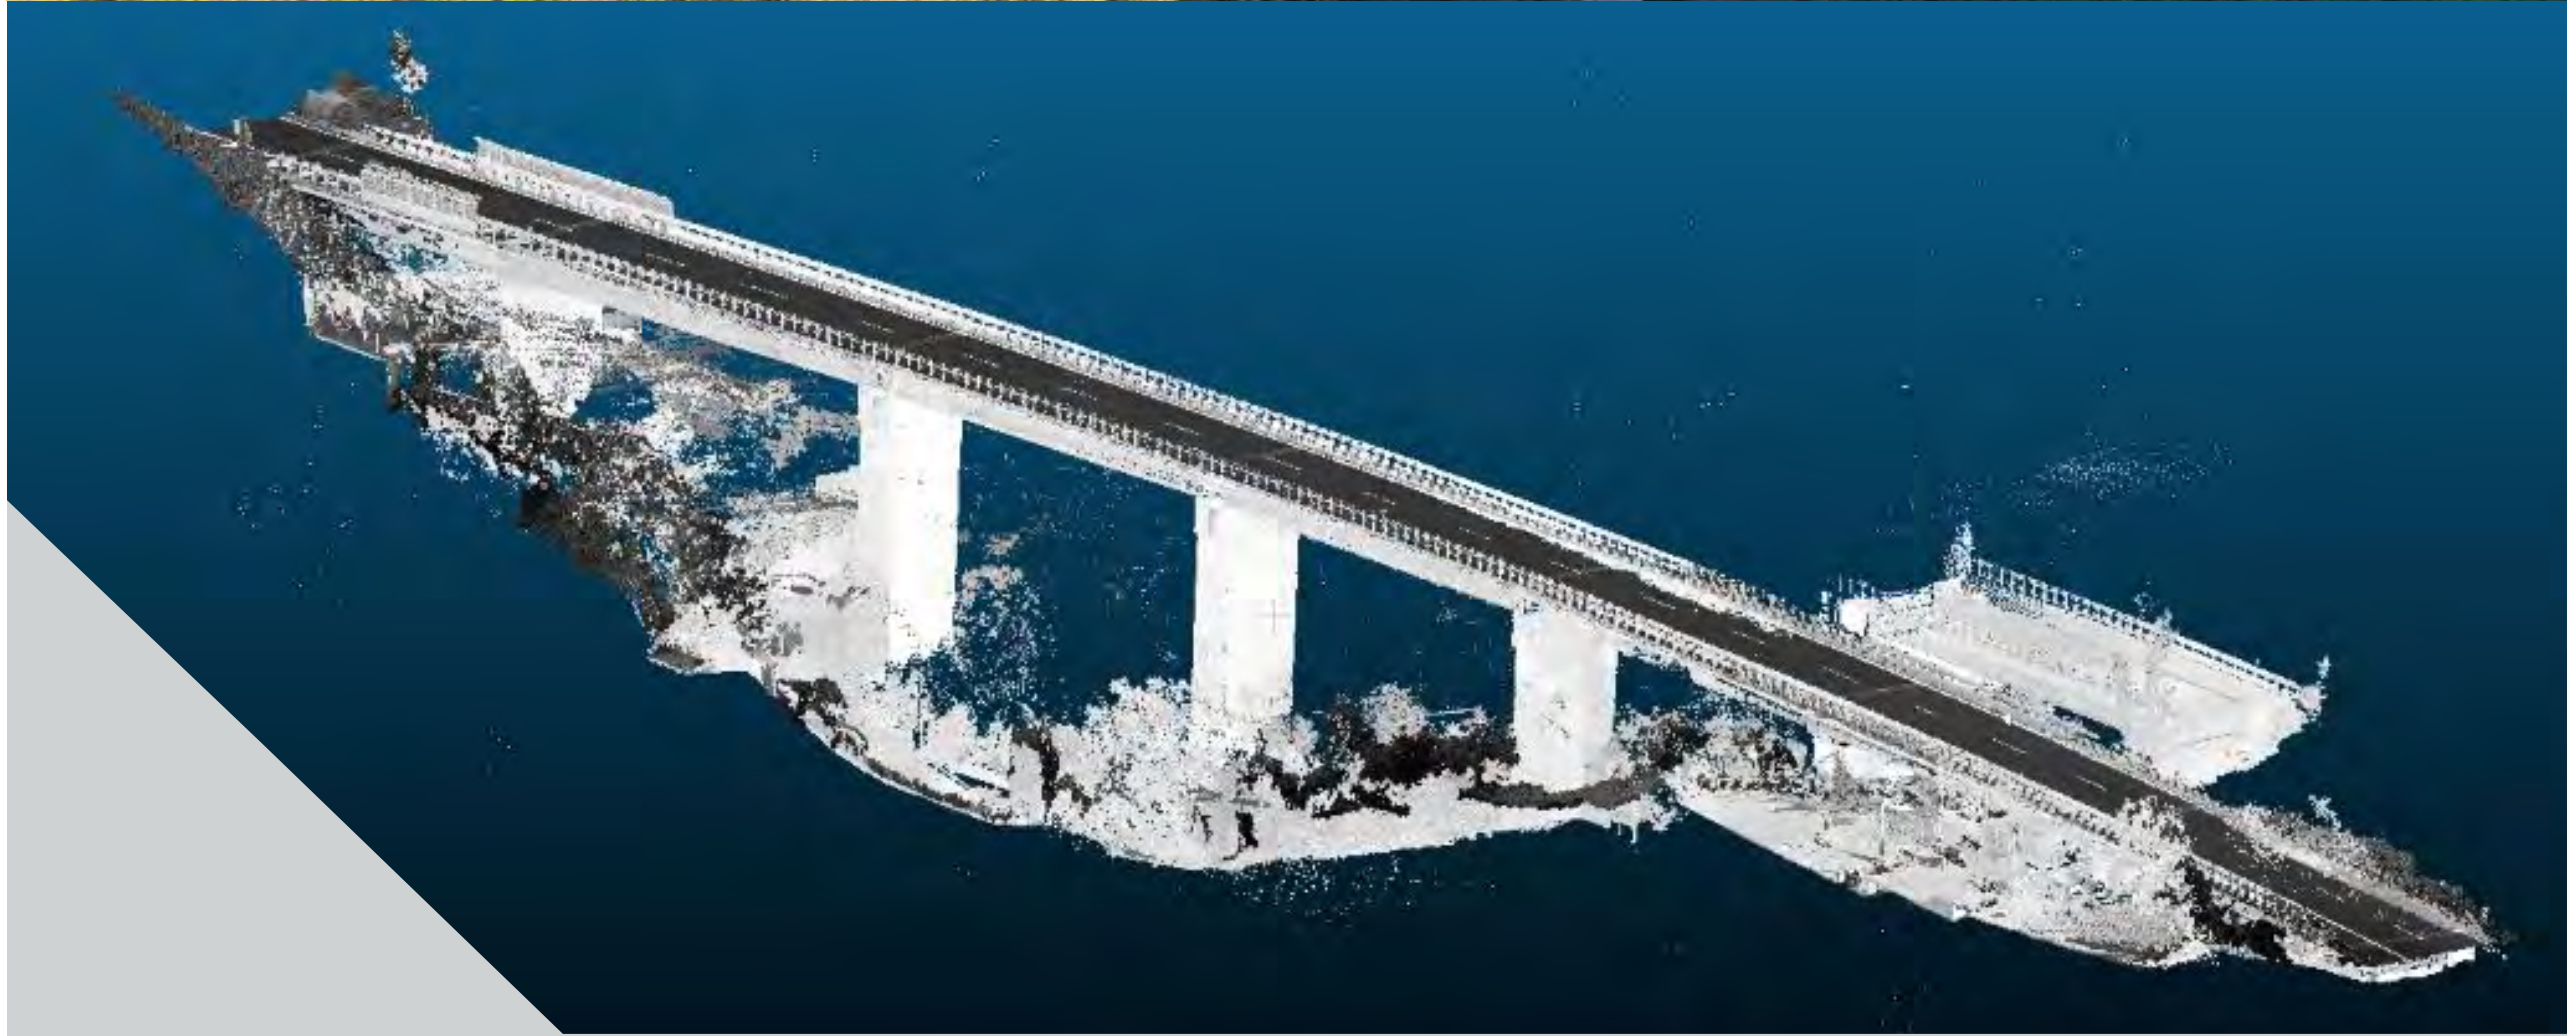
# Messina–Catania Highway

Census, primary visual inspections and determination of the state of conservation of bridges and viaducts on the Messina-Catania Highway

For proper planning, all works were pre-viewed and geolocated via GPS coordinates by inserting them into a Google Earth file that served as a reference for any problem of access or interference with other minor works and for all subsequent stages. The intervention carried out included a first phase of work in which the surveys were carried out with total station and point clouds, subsequently the visual inspections were executed according to the LL.GG. of the MIT passing any type of orographic or artificial obstacle through the use of drones and mountaineering techniques. In the post-processing phase, the data sourced for the compilation of the census by means of boundary data sourced though painstaking research on the historical, landscape, hydraulic and geological documentation of the area, performed for each work. Subsequently, for the works that highlighted the need for more accurate verification, the investigation plans were carried out and the related tests as well. Each phase was done in accordance with the ‘Guidelines for Risk Classification and Management, Safety Assessment and Monitoring of Existing Bridges’ of the Ministry of Infrastructure and Transport.

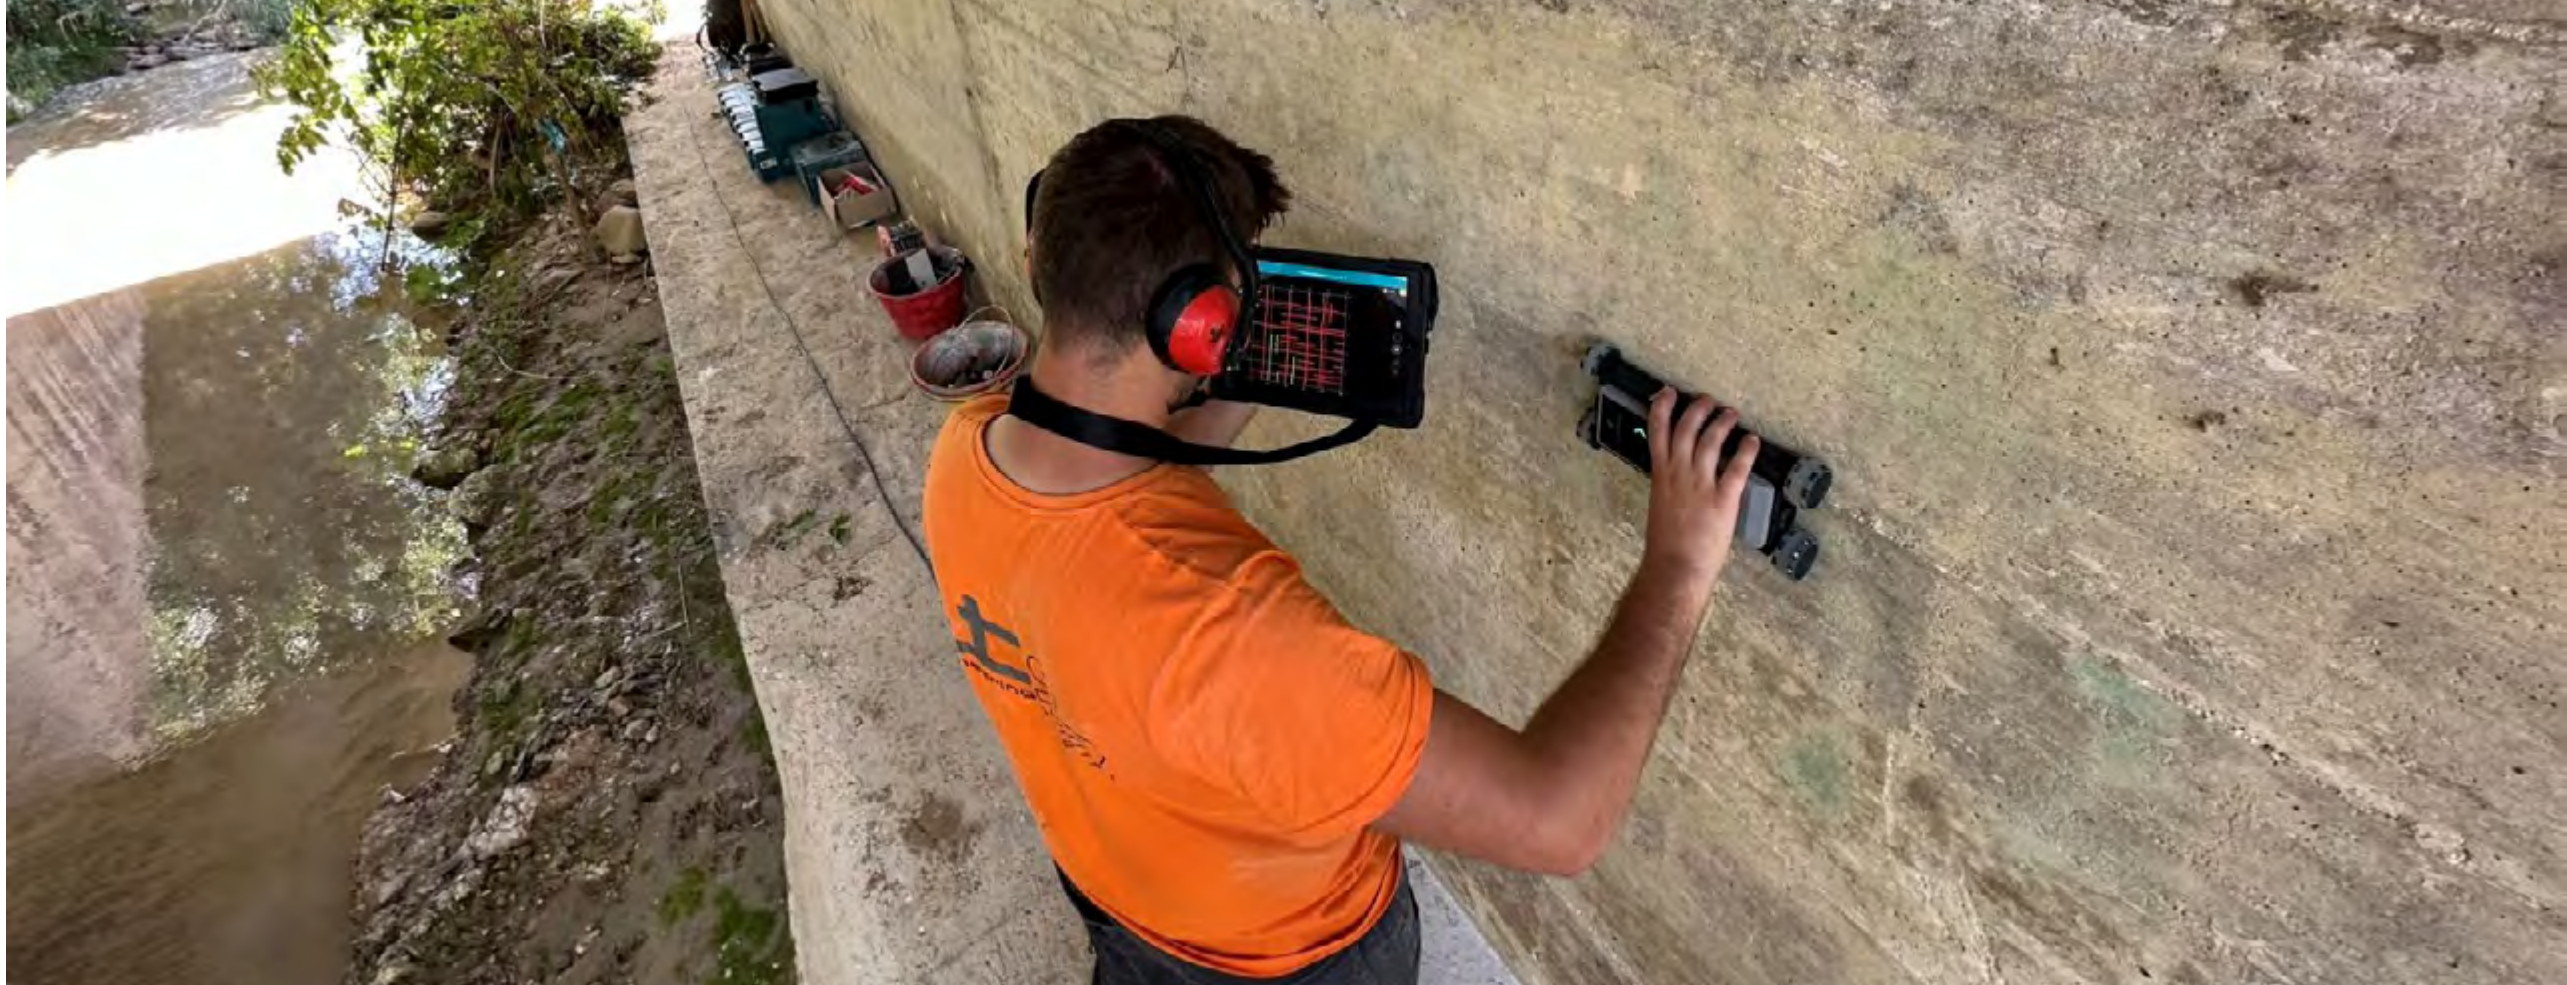
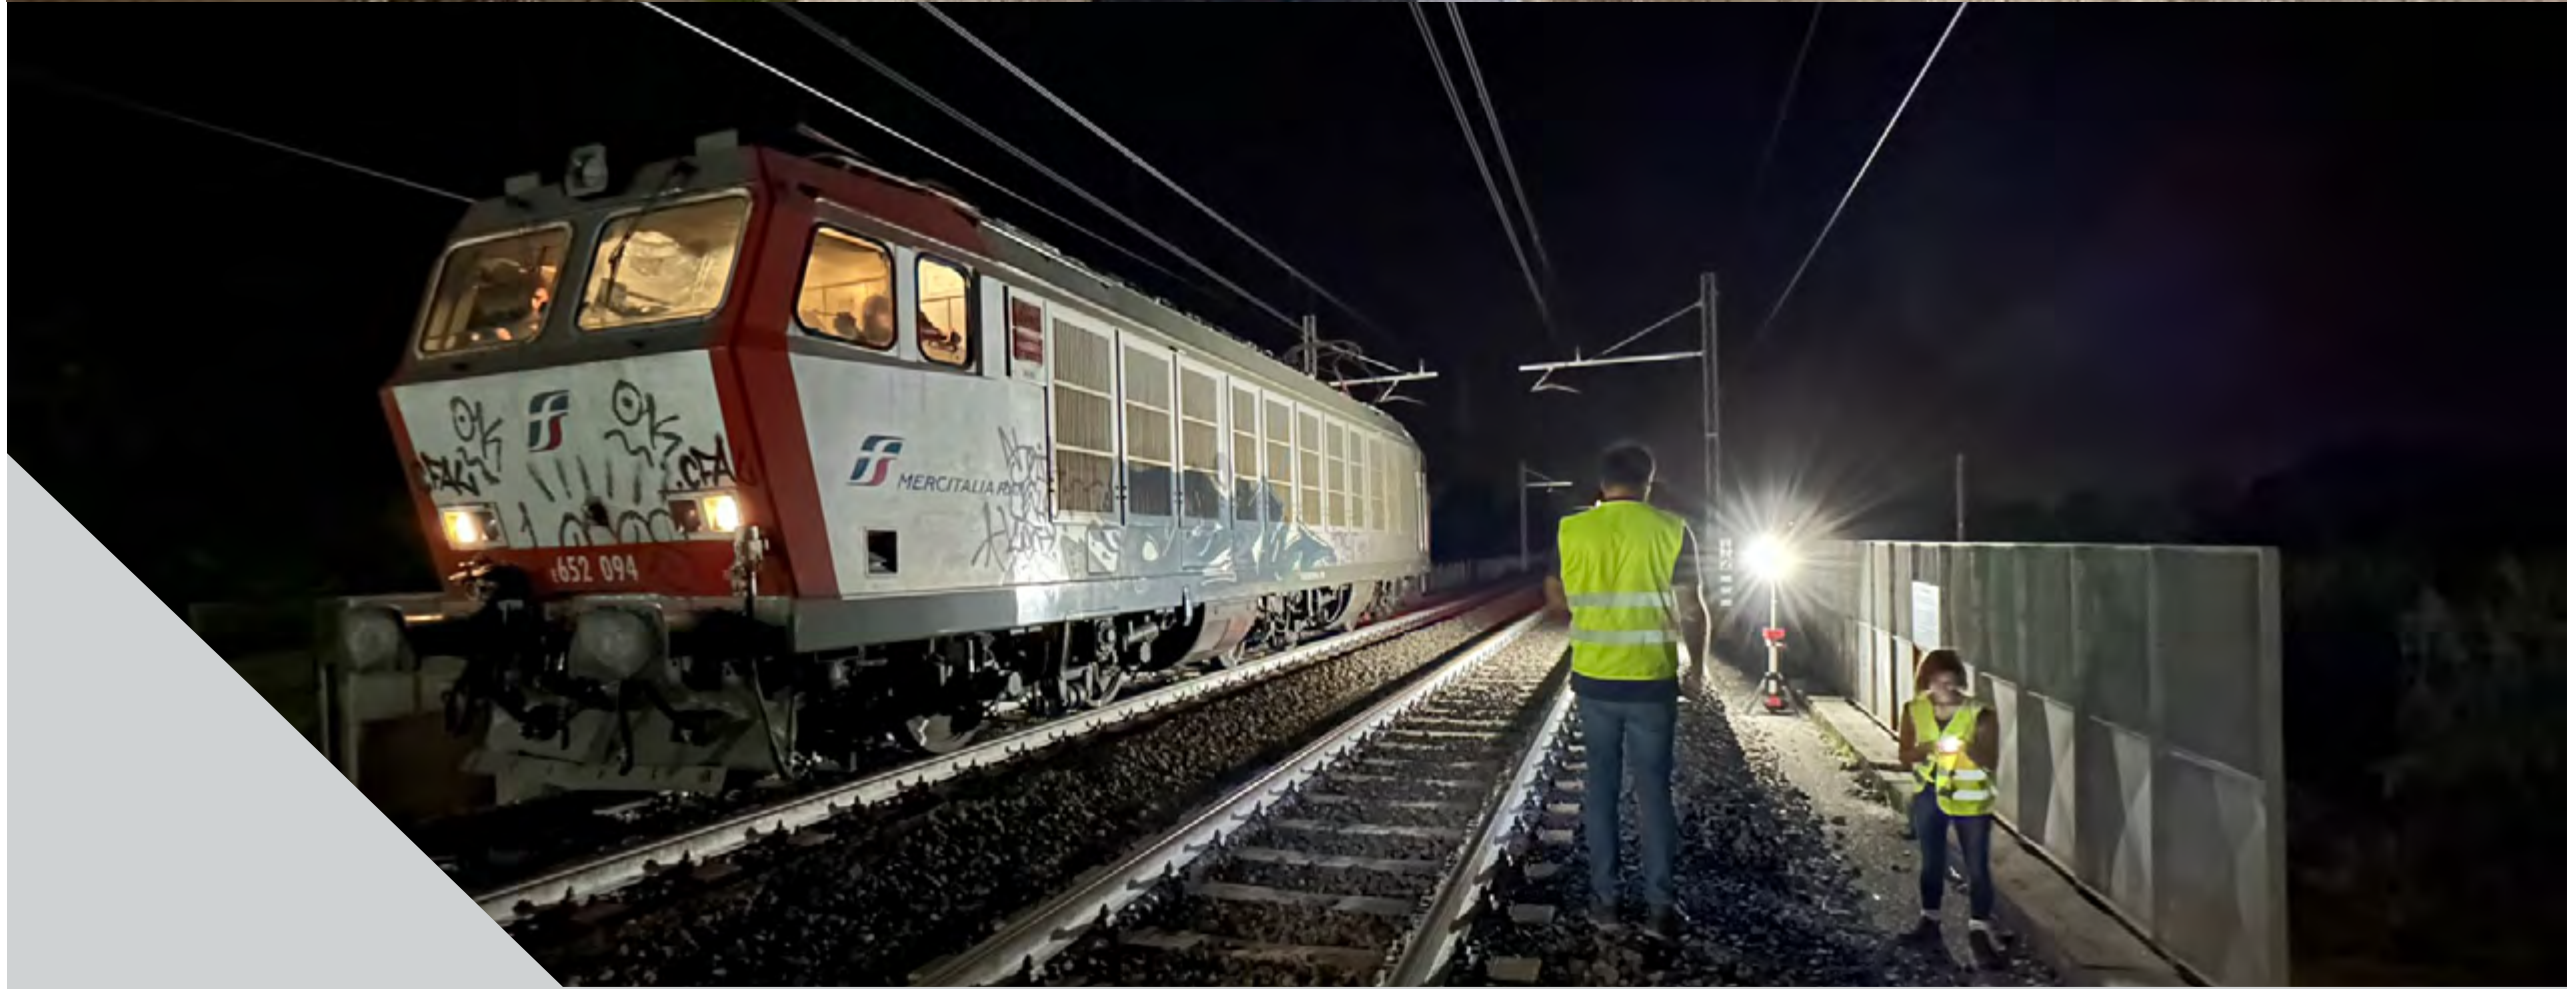
# Italferr Framework Agreement

Structural monitoring activities, execution of destructive and non-destructive investigations and detailed geometric surveys on existing structures

The Inspection team worked from time to time with the contacts of Italferr (the engineering company of Ferrovie dello Stato Italiane Group) with initial coordination phases in which operational procedures and feasibility of the investigation plans were discussed, optimizing the interventions and tests to be carried out according to the individual typological interventions, thanks to the well-standing and long experience of the team in the field of investigations. Geometric surveys and structural investigations were carried out on several types of structures, both on buildings and warehouses of the maintenance department, and on the works along the railway lines such as bridges and sub-via managed by Italferr throughout the national territory. In contexts sometimes prohibitive for the unique morphological conditions of the sites, where from time to time the most appropriate solutions have been found to be used, such as the use of boats to inspect and investigate pond piles, the adoption of work at night to limit the inconvenience attributable to the interruptions of railway lines.

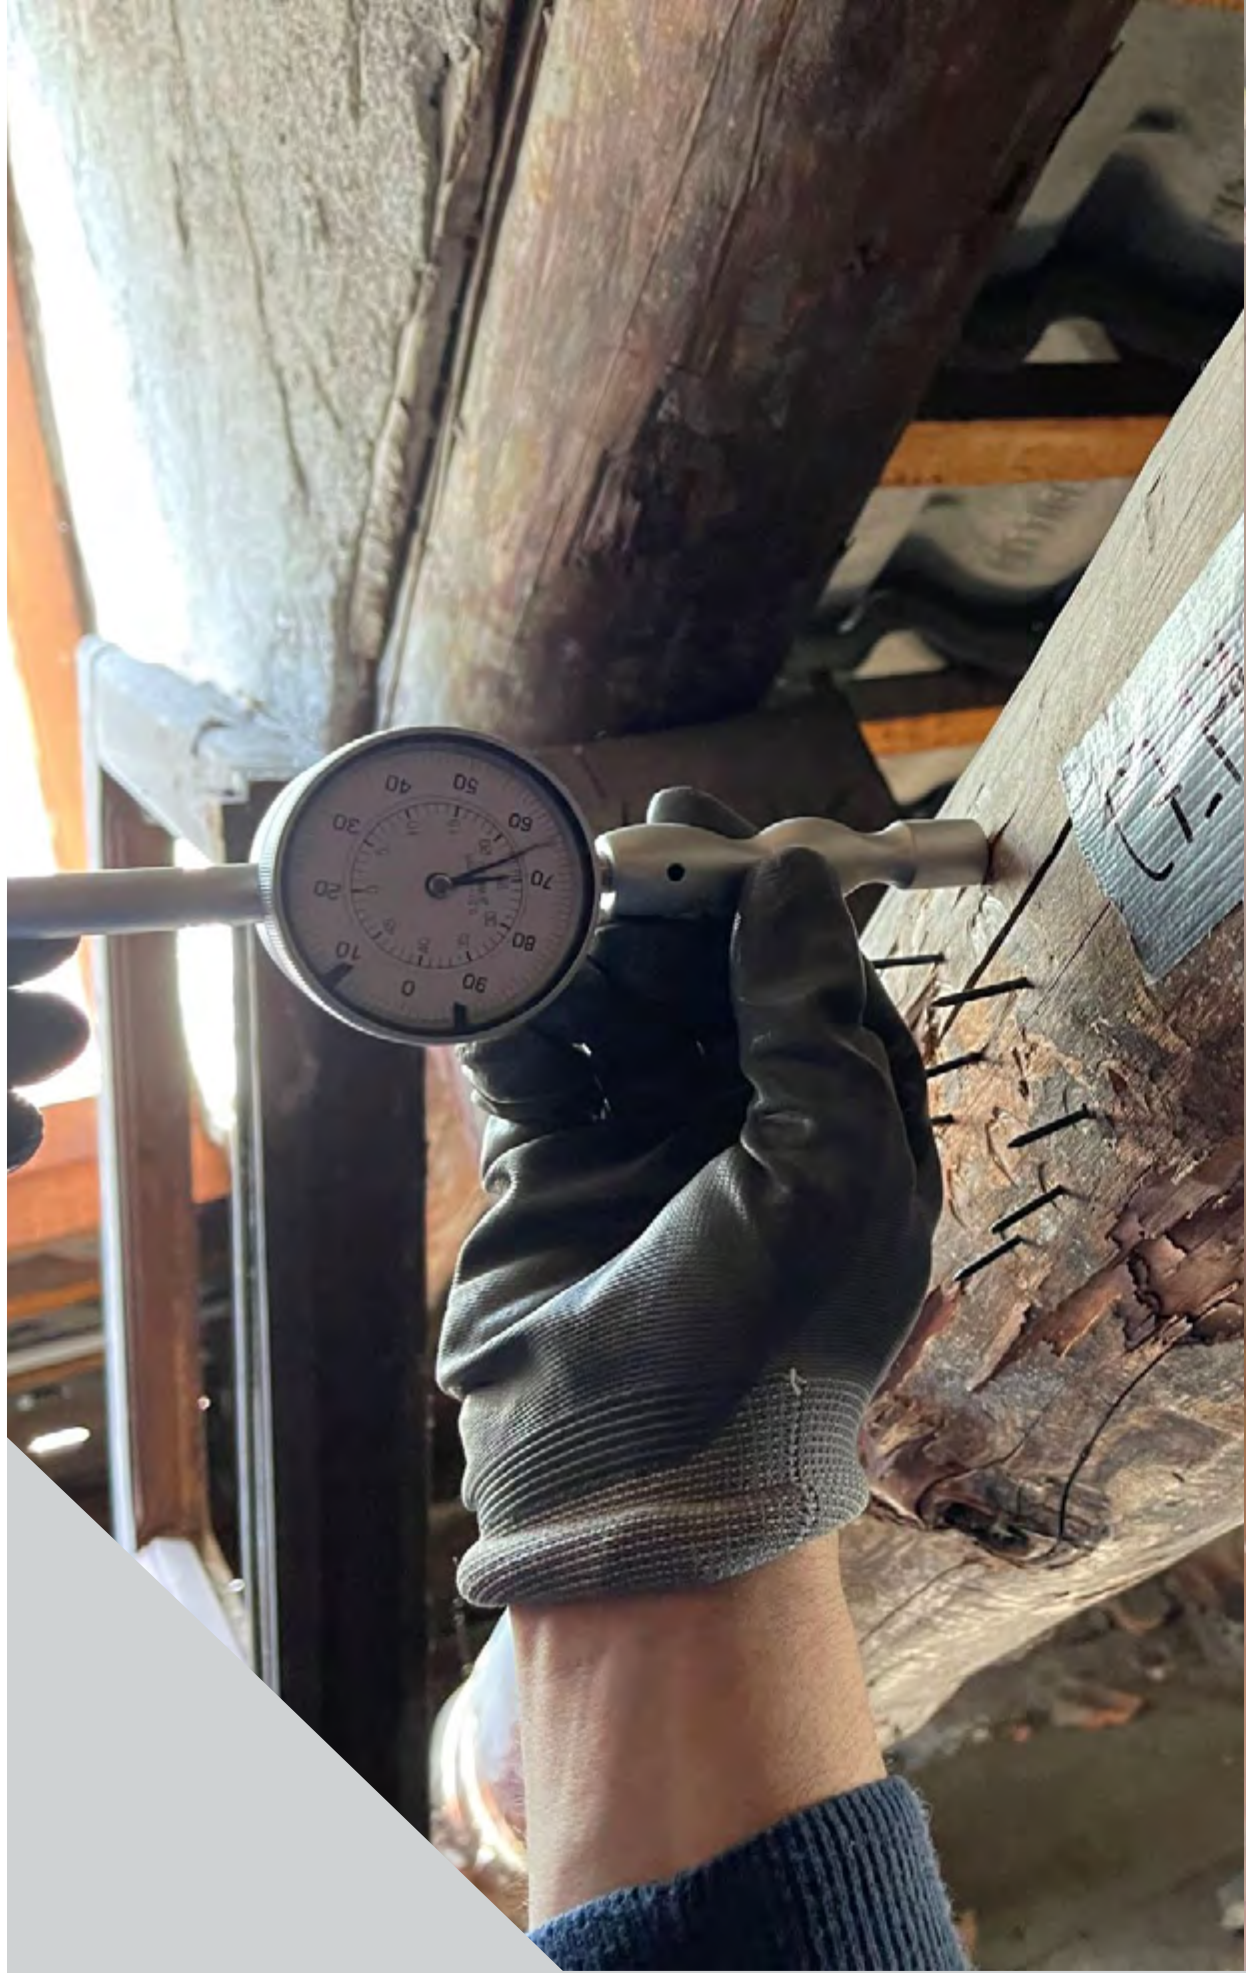
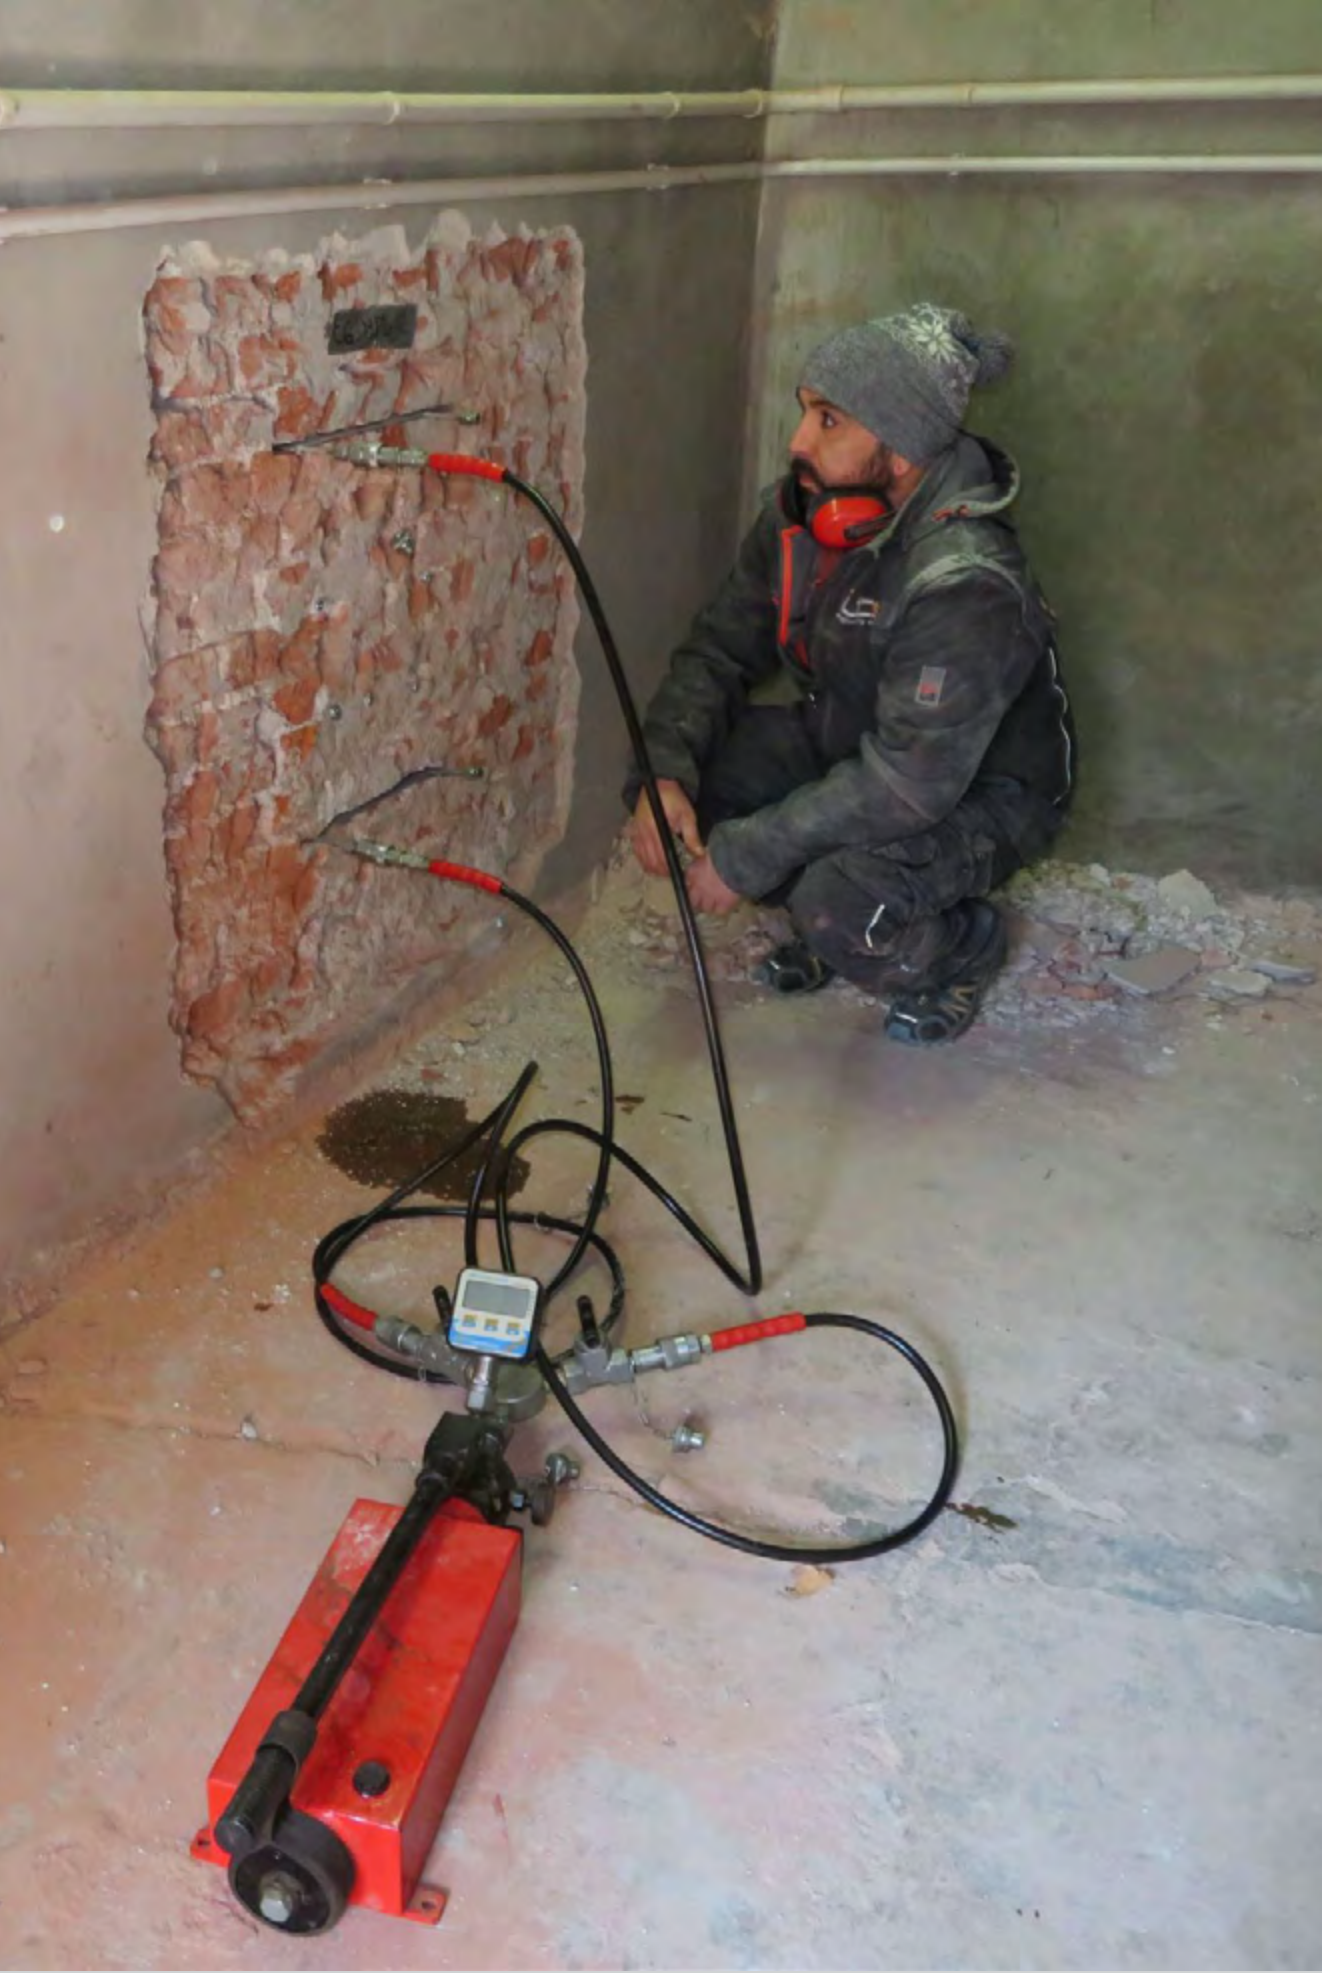
# Agency of State Property - Masonry Inspections

Geometric, architectural and technological surveys with structural investigations and BIM models, energy diagnosis and vulnerability analysis

The Agenzia del Demanio (Property Agency) owns a significant portion of the State owned properties in Italy. It is crucial to have a clear and comprehensive overview of the static and seismic conditions of these various buildings and to be aware of any need for seismic retrofitting or improvement. The Inspection team conducted site visits to all the structures to identify any critical issues and develop customized investigation plans. Detailed topographic surveys were conducted on every type of building using total stations and laser scanners, with the data returned via Revit 3D, from which the plans were derived to create the necessary investigation plan to achieve a Level 3 of knowledge. Investigations were carried out on all types of structures, whether masonry, reinforced concrete, or steel, by technicians qualified for both destructive and nondestructive testing (NDT). Using ITS equipment, tests such as double and single flat jack tests, penetrometric tests, core drilling, localized scabbling, sclerometric tests, ultrasonic tests, rebar sampling, load tests, and foundation coring were conducted. The data obtained were used for structural modeling and vulnerability analysis, with the final phase involving the preparation of a PFTE based on the results.
