# INSPECTION DEPARTMENT

Brochure

# The Department

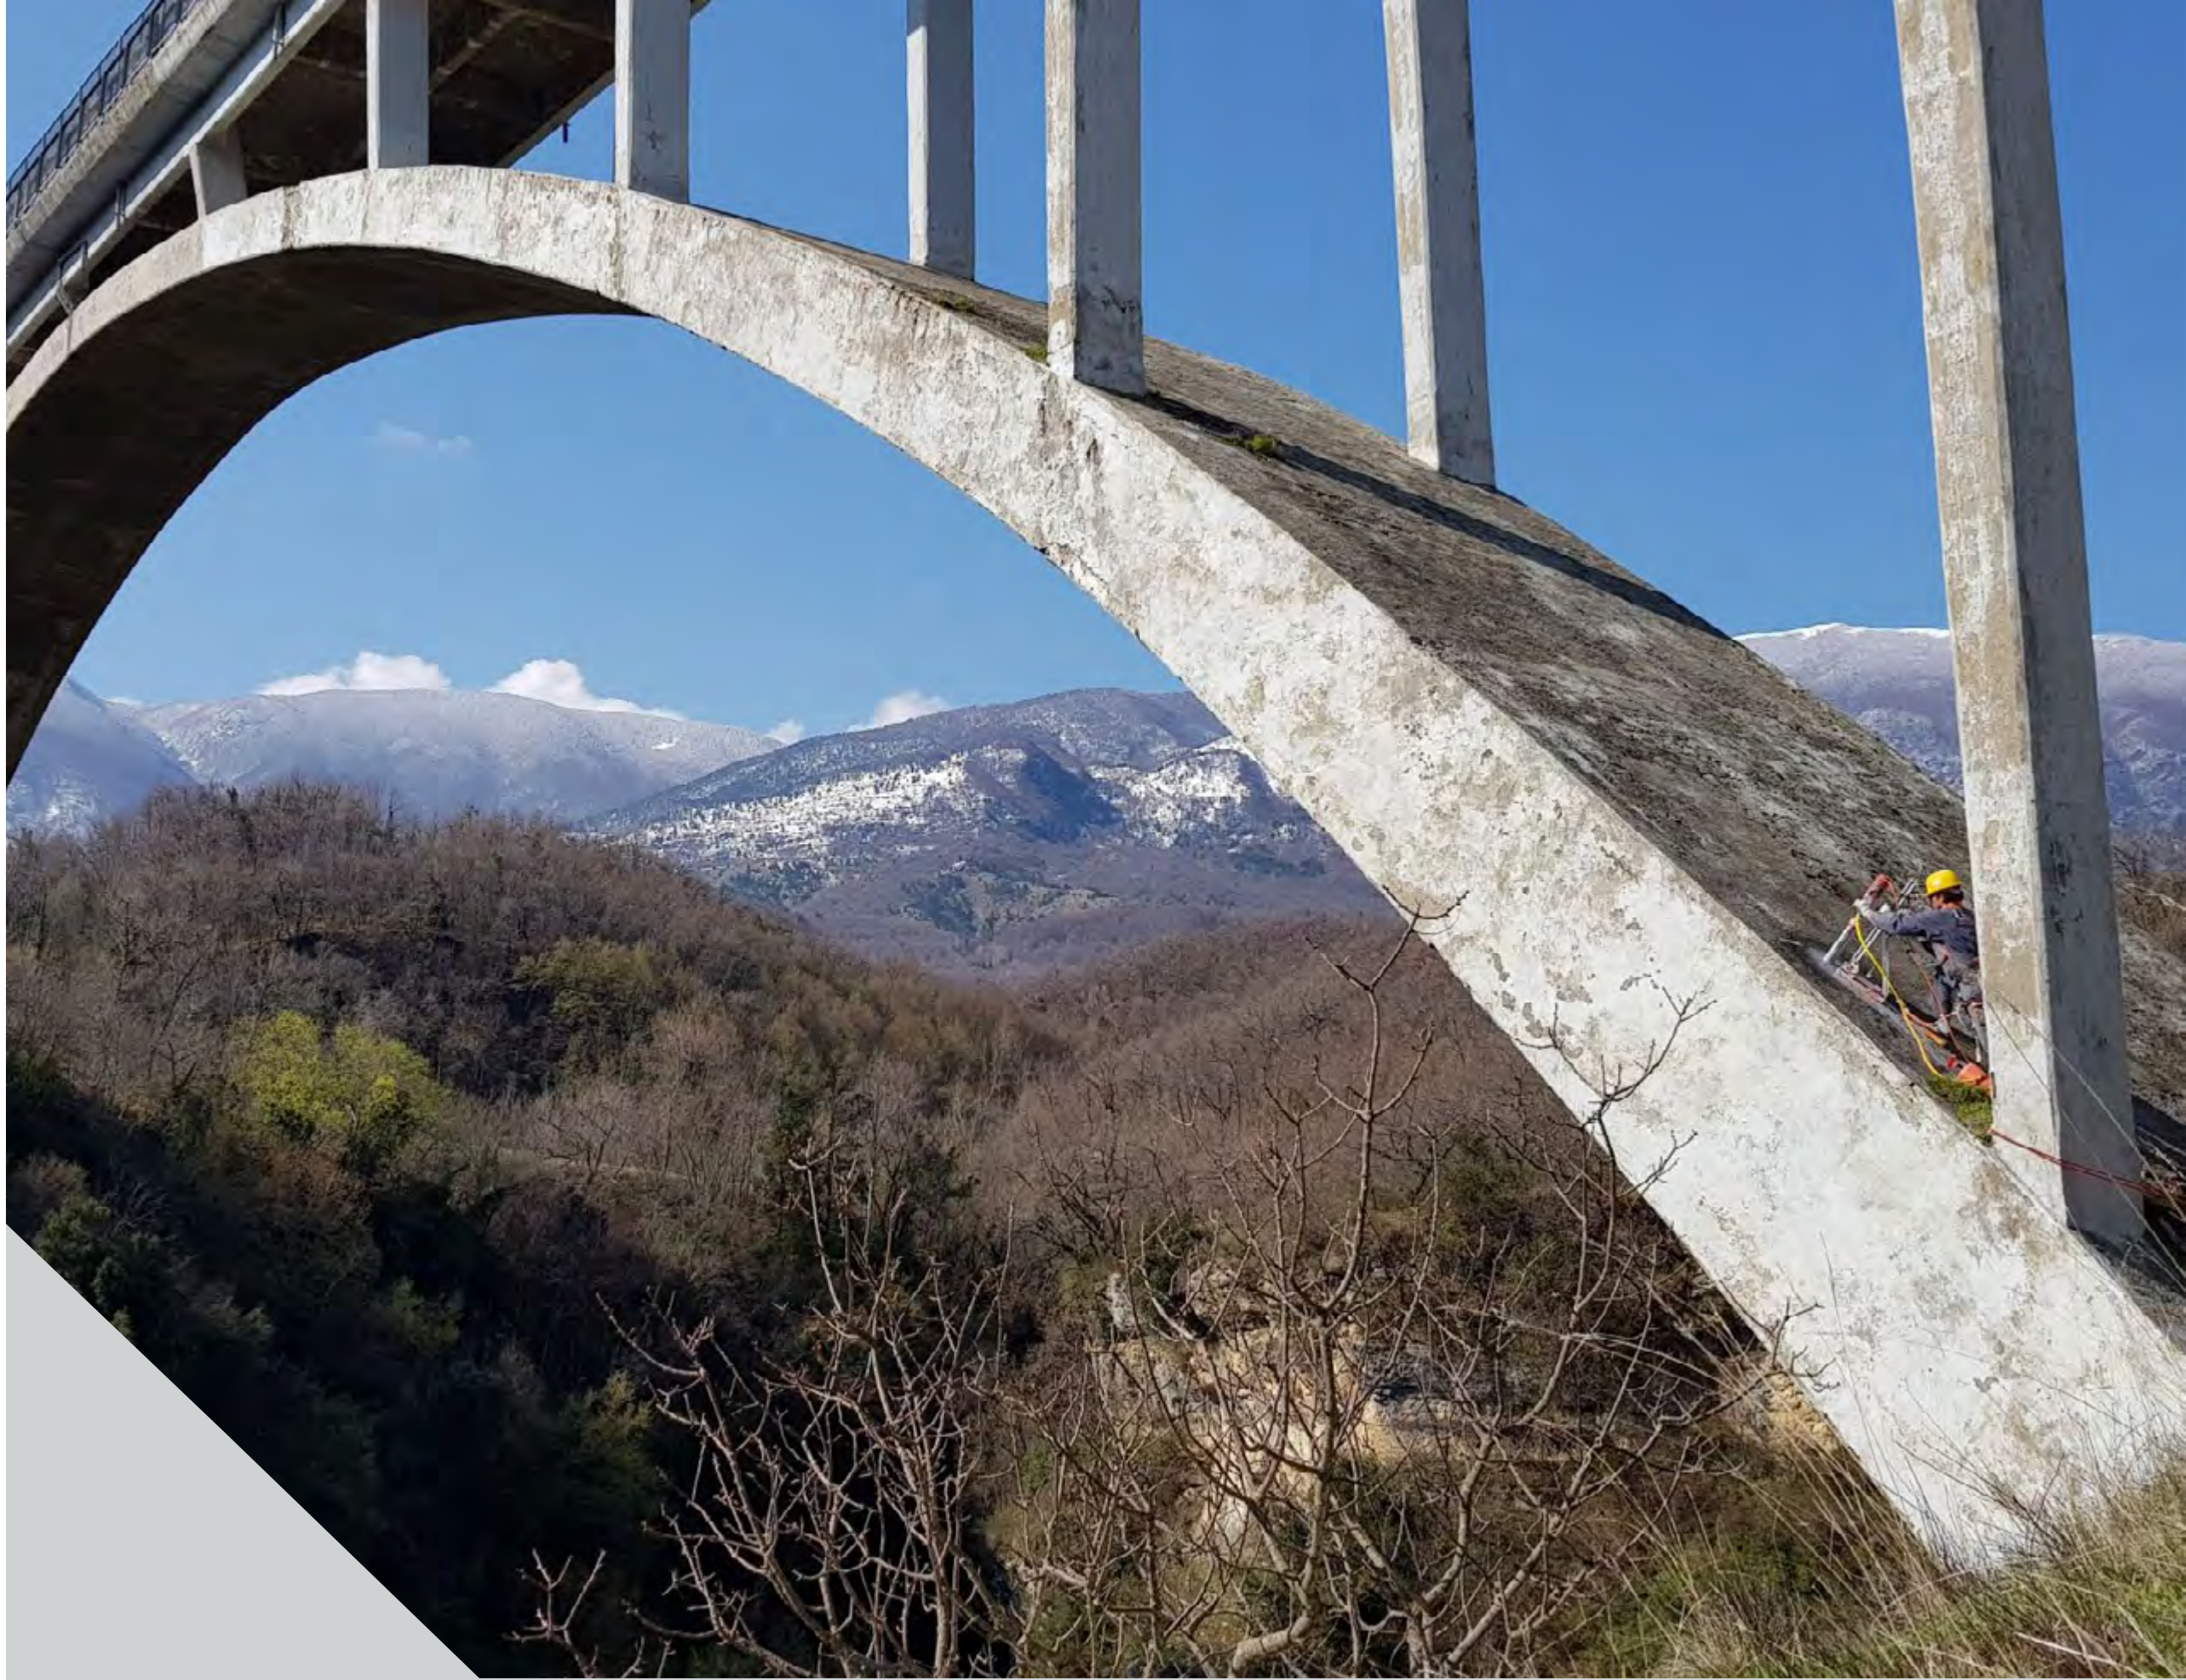
# Road Bridges and Viaducts in the province of Pescara

Inspection, investigation, and verification of static and seismic vulnerability of infrastructure in the province of Pescara

The service included a seismic analysis of 13 structures in the Province of Pescara, independently performing activities such as surveys, investigations, on-site and laboratory tests, monitoring, and sampling for the characterization of existing works of art on the road network in the Province of Pescara. The investigations were carried out on 11 bridges and 2 viaducts. In various cases, detailed structural surveys were conducted using a mechanical total station of the Trimble M3 type, equipped with high-precision Trimble DR long-range survey technology to obtain highly reliable measurements. Various types of tests were conducted to achieve a high level of accuracy (LC3). For example, on structures: core drilling, micro-core drilling, reinforcement sampling, pacometric testing. On the subsoil: seismic surveys with Multichannel Analysis of Surface Waves (MASW), passive seismic investigations (Horizontal-to-Vertical Spectral Ratio - HVSR), and geomechanical surveys. For each structure, vulnerability checks for seismic actions were carried out with FEM modeling, created using MIDAS GEN software, involving three-dimensional modeling of structures based on surveyed geometries, using exclusively fiber-modeled beam elements so that they capture the nonlinearity of materials and have the same mechanical characteristics as those detected during on-site investigations.

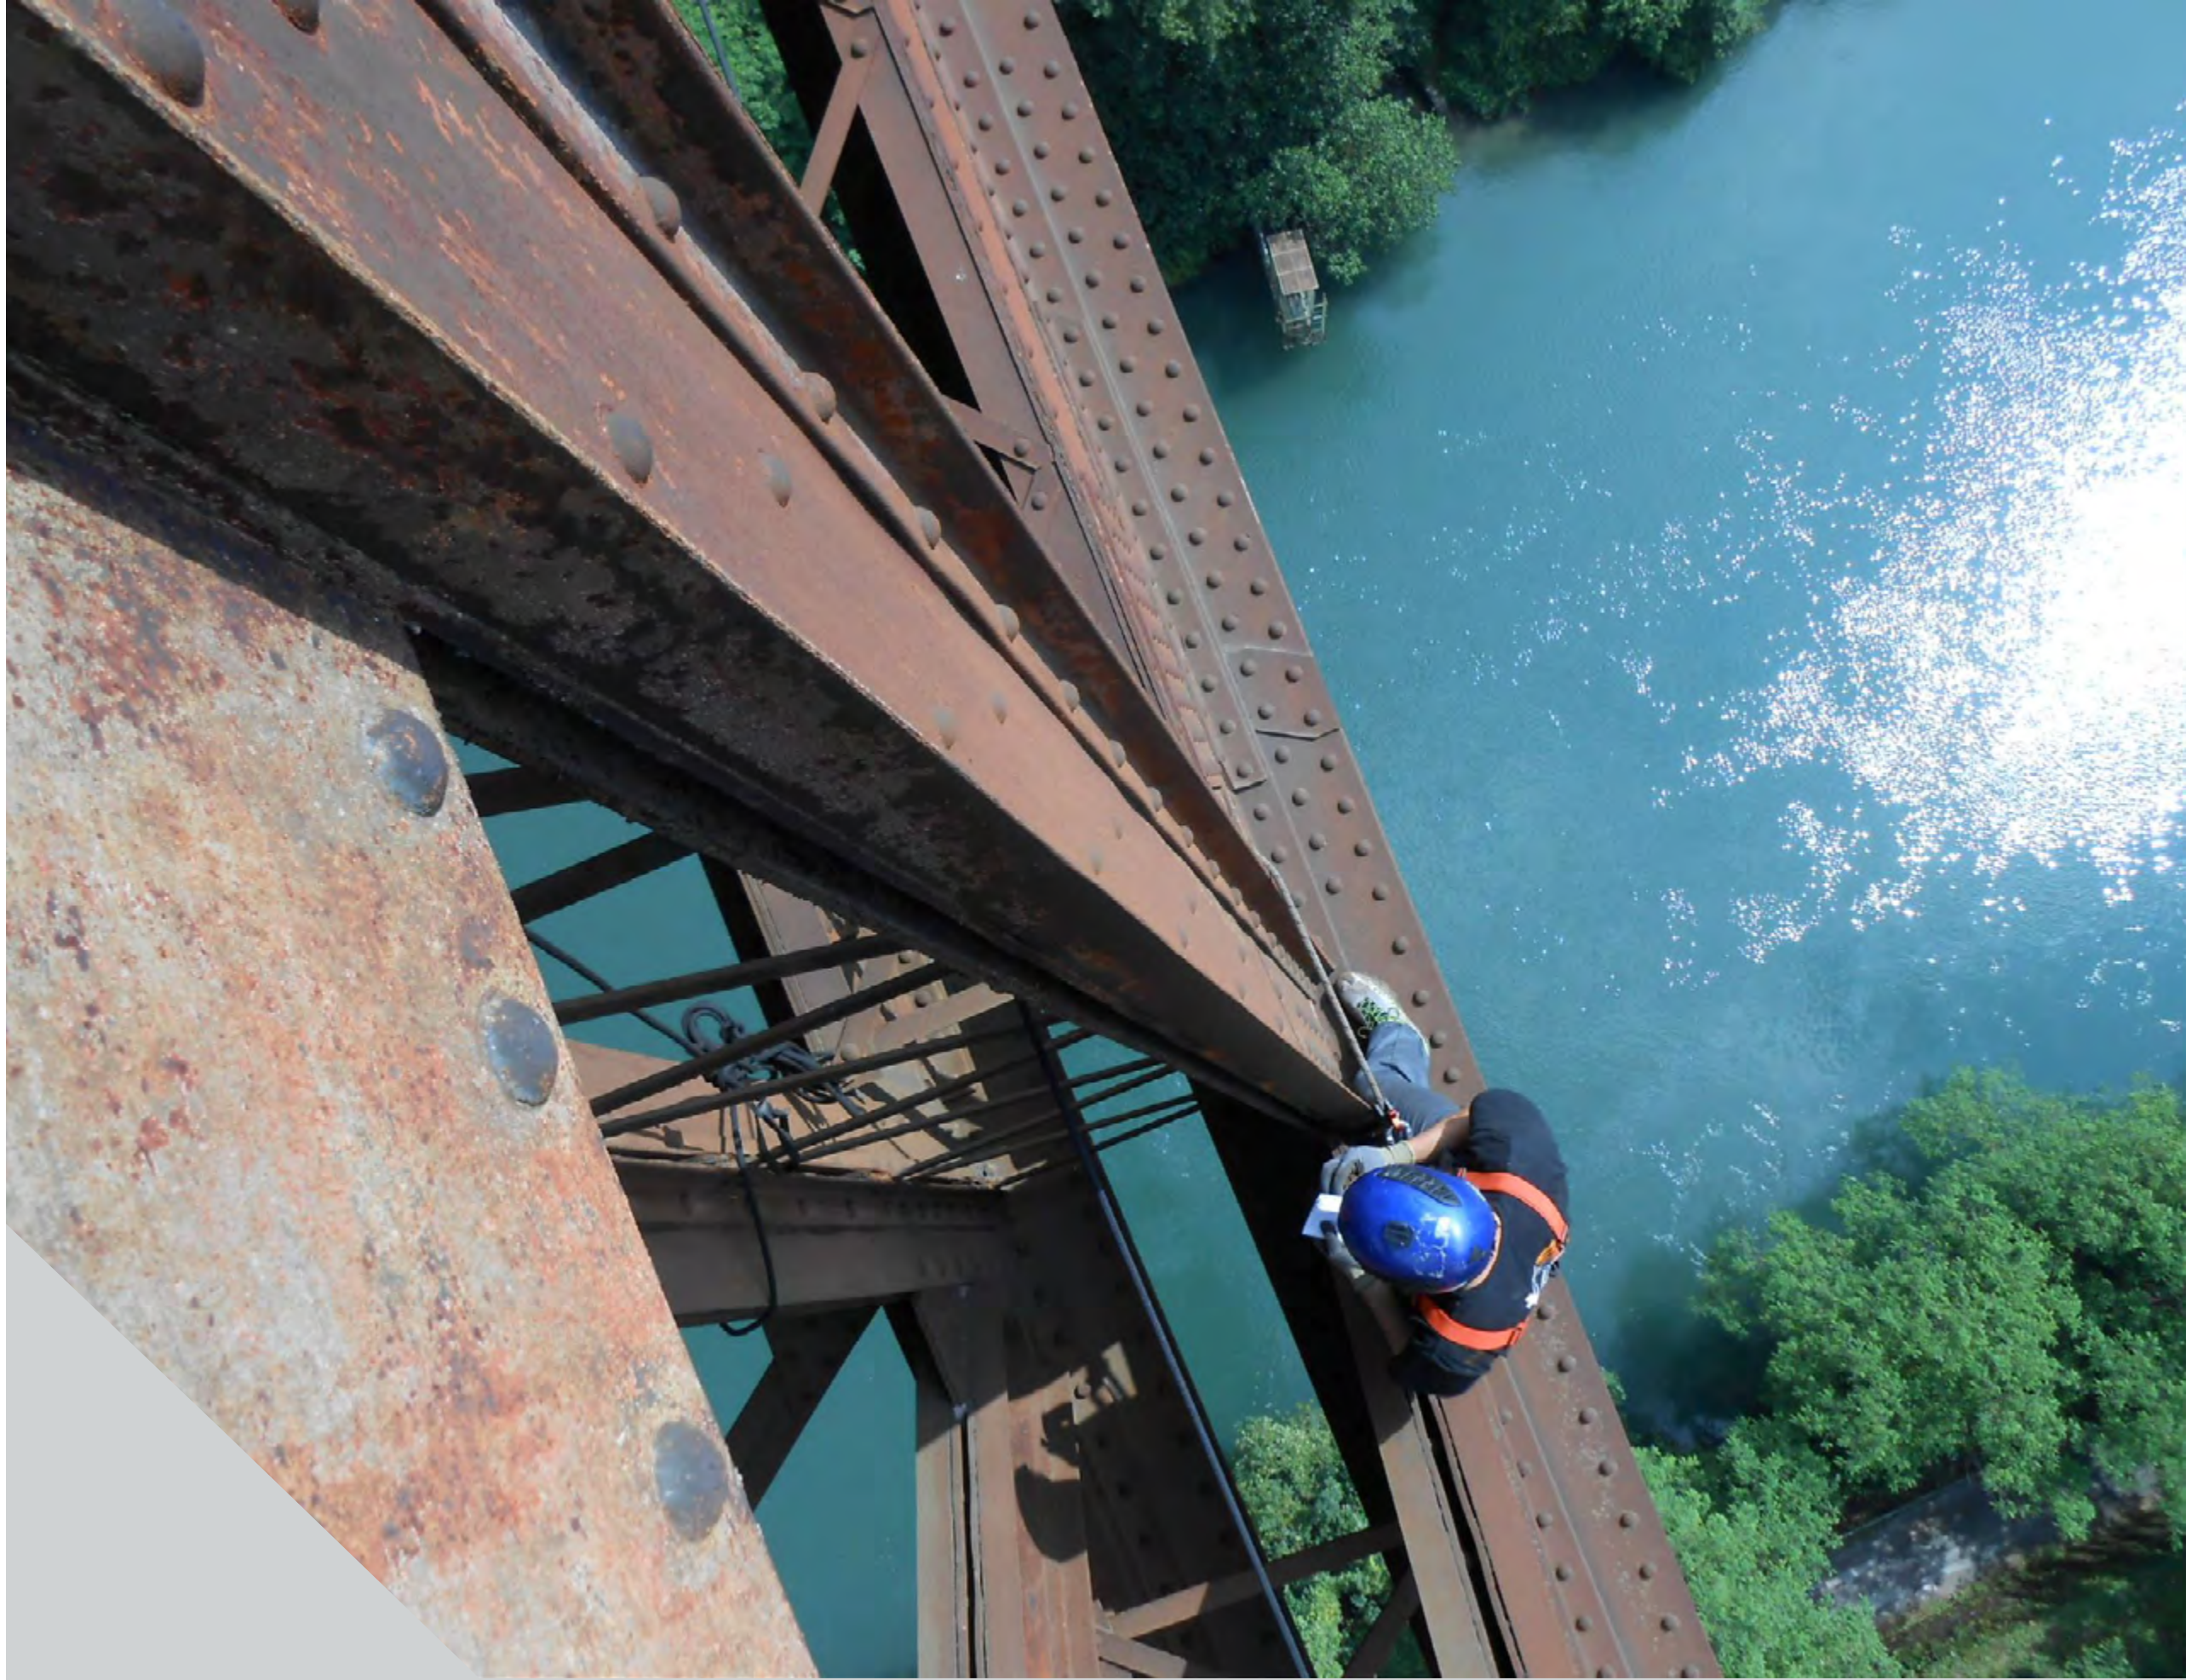
# San Michele Bridge

A comprehensive inspection campaign was carried out to survey and map the actual state of deterioration of all parts of the structure. The inspection was conducted by structural engineers using rope-access techniques, ensuring proximity of less than 1.5 meters to all structural elements.

Investigations and tests were performed on the main structural components with the objective of achieving a Level of Knowledge 3 (LC3), in accordance with current regulations for existing bridges. Mechanical characterization included:

- Destructive testing on structural steel (sampling of bars and rivets; laboratory tests on tensile strength, shear strength, toughness, and chemical composition);
- Non-destructive testing on structural steel (Visual Testing - VT, Magnetic Particle Testing - MT);
- Foundation investigations (core sampling and uniaxial compression tests);
- Asphalt surveys (drilling and thickness measurements).

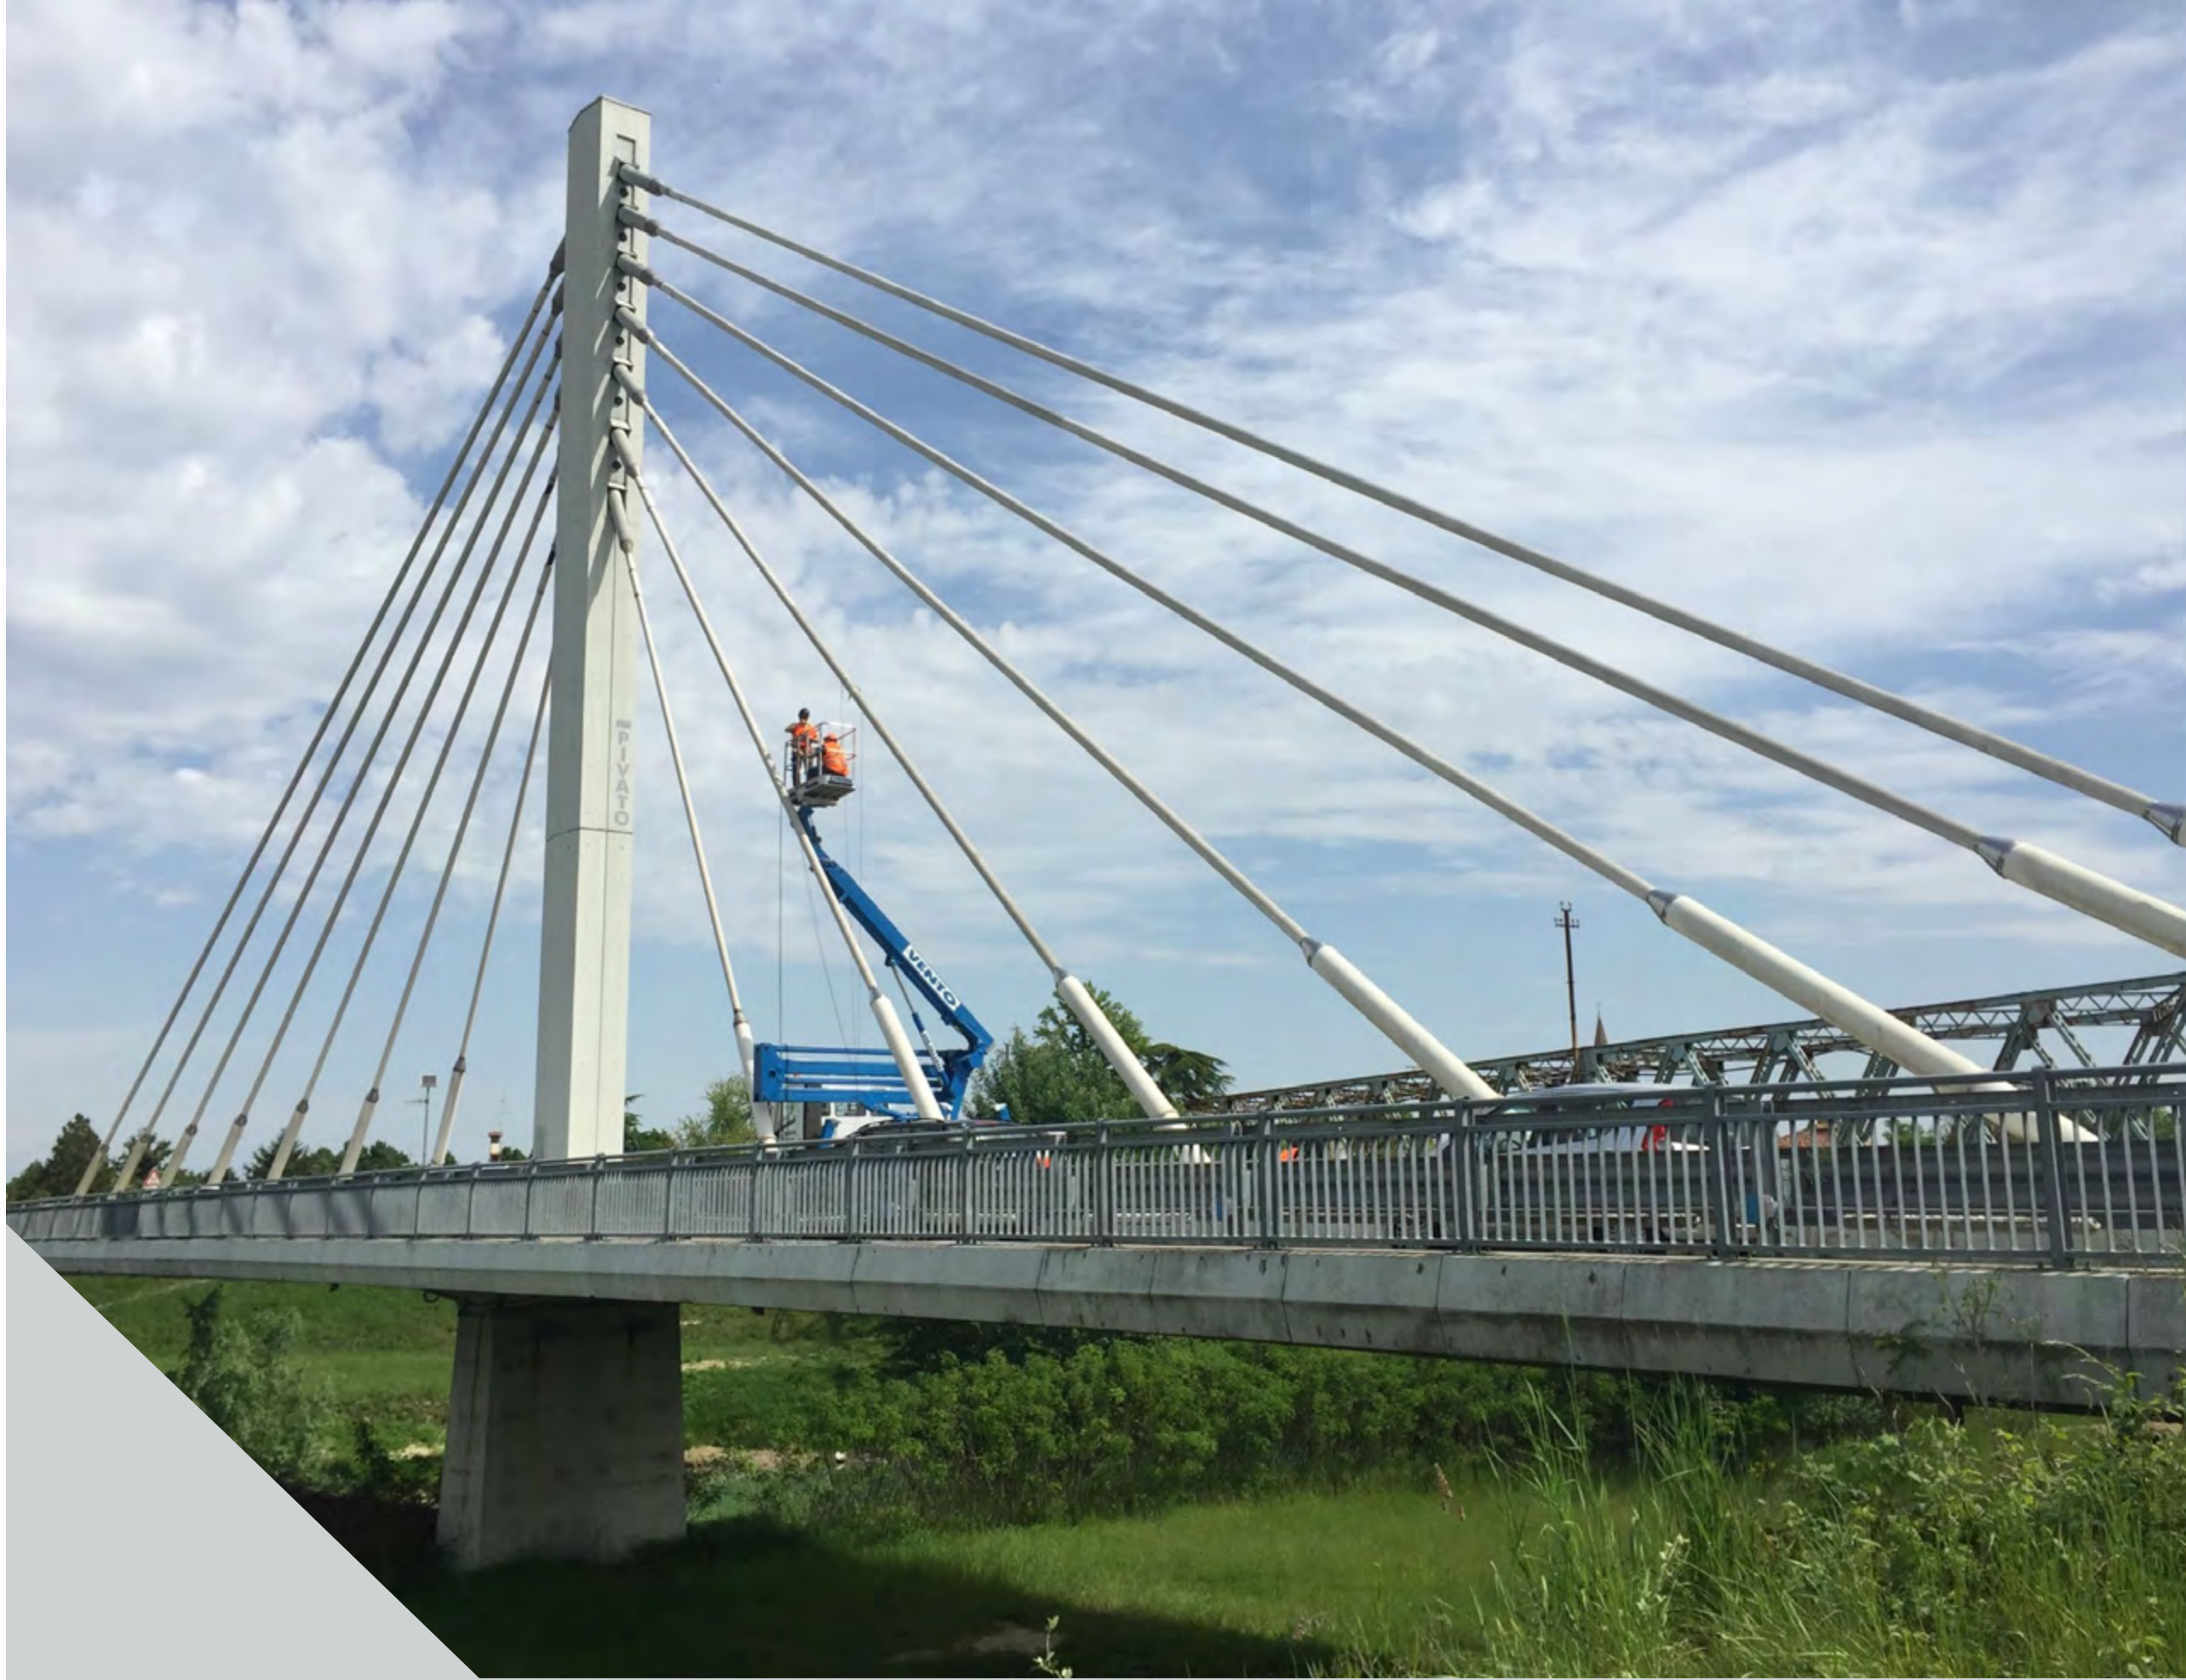
# Livenza Bridge

Inspections of the structural elements of the cable-stayed bridge along the “Meduna Road” over the Livenza River in the municipalities of Motta and Meduna di Livenza

- Visual inspection of all the anchor tie rods placed at the shoulder Motta side of Livenza;
- Visual inspection of the steel at the antenna head;
- Visual inspection of all the cables with restoration of the sleeves that have had slips on the protective sheaths of the cables;
- Control of the base and top heads with restoration/replacement of the protective grease;
- Dynamic control of all the cables with the indirect determination of the internal tension;
- Visual inspection of the expansion joints;
- Visual inspection of the support devices.

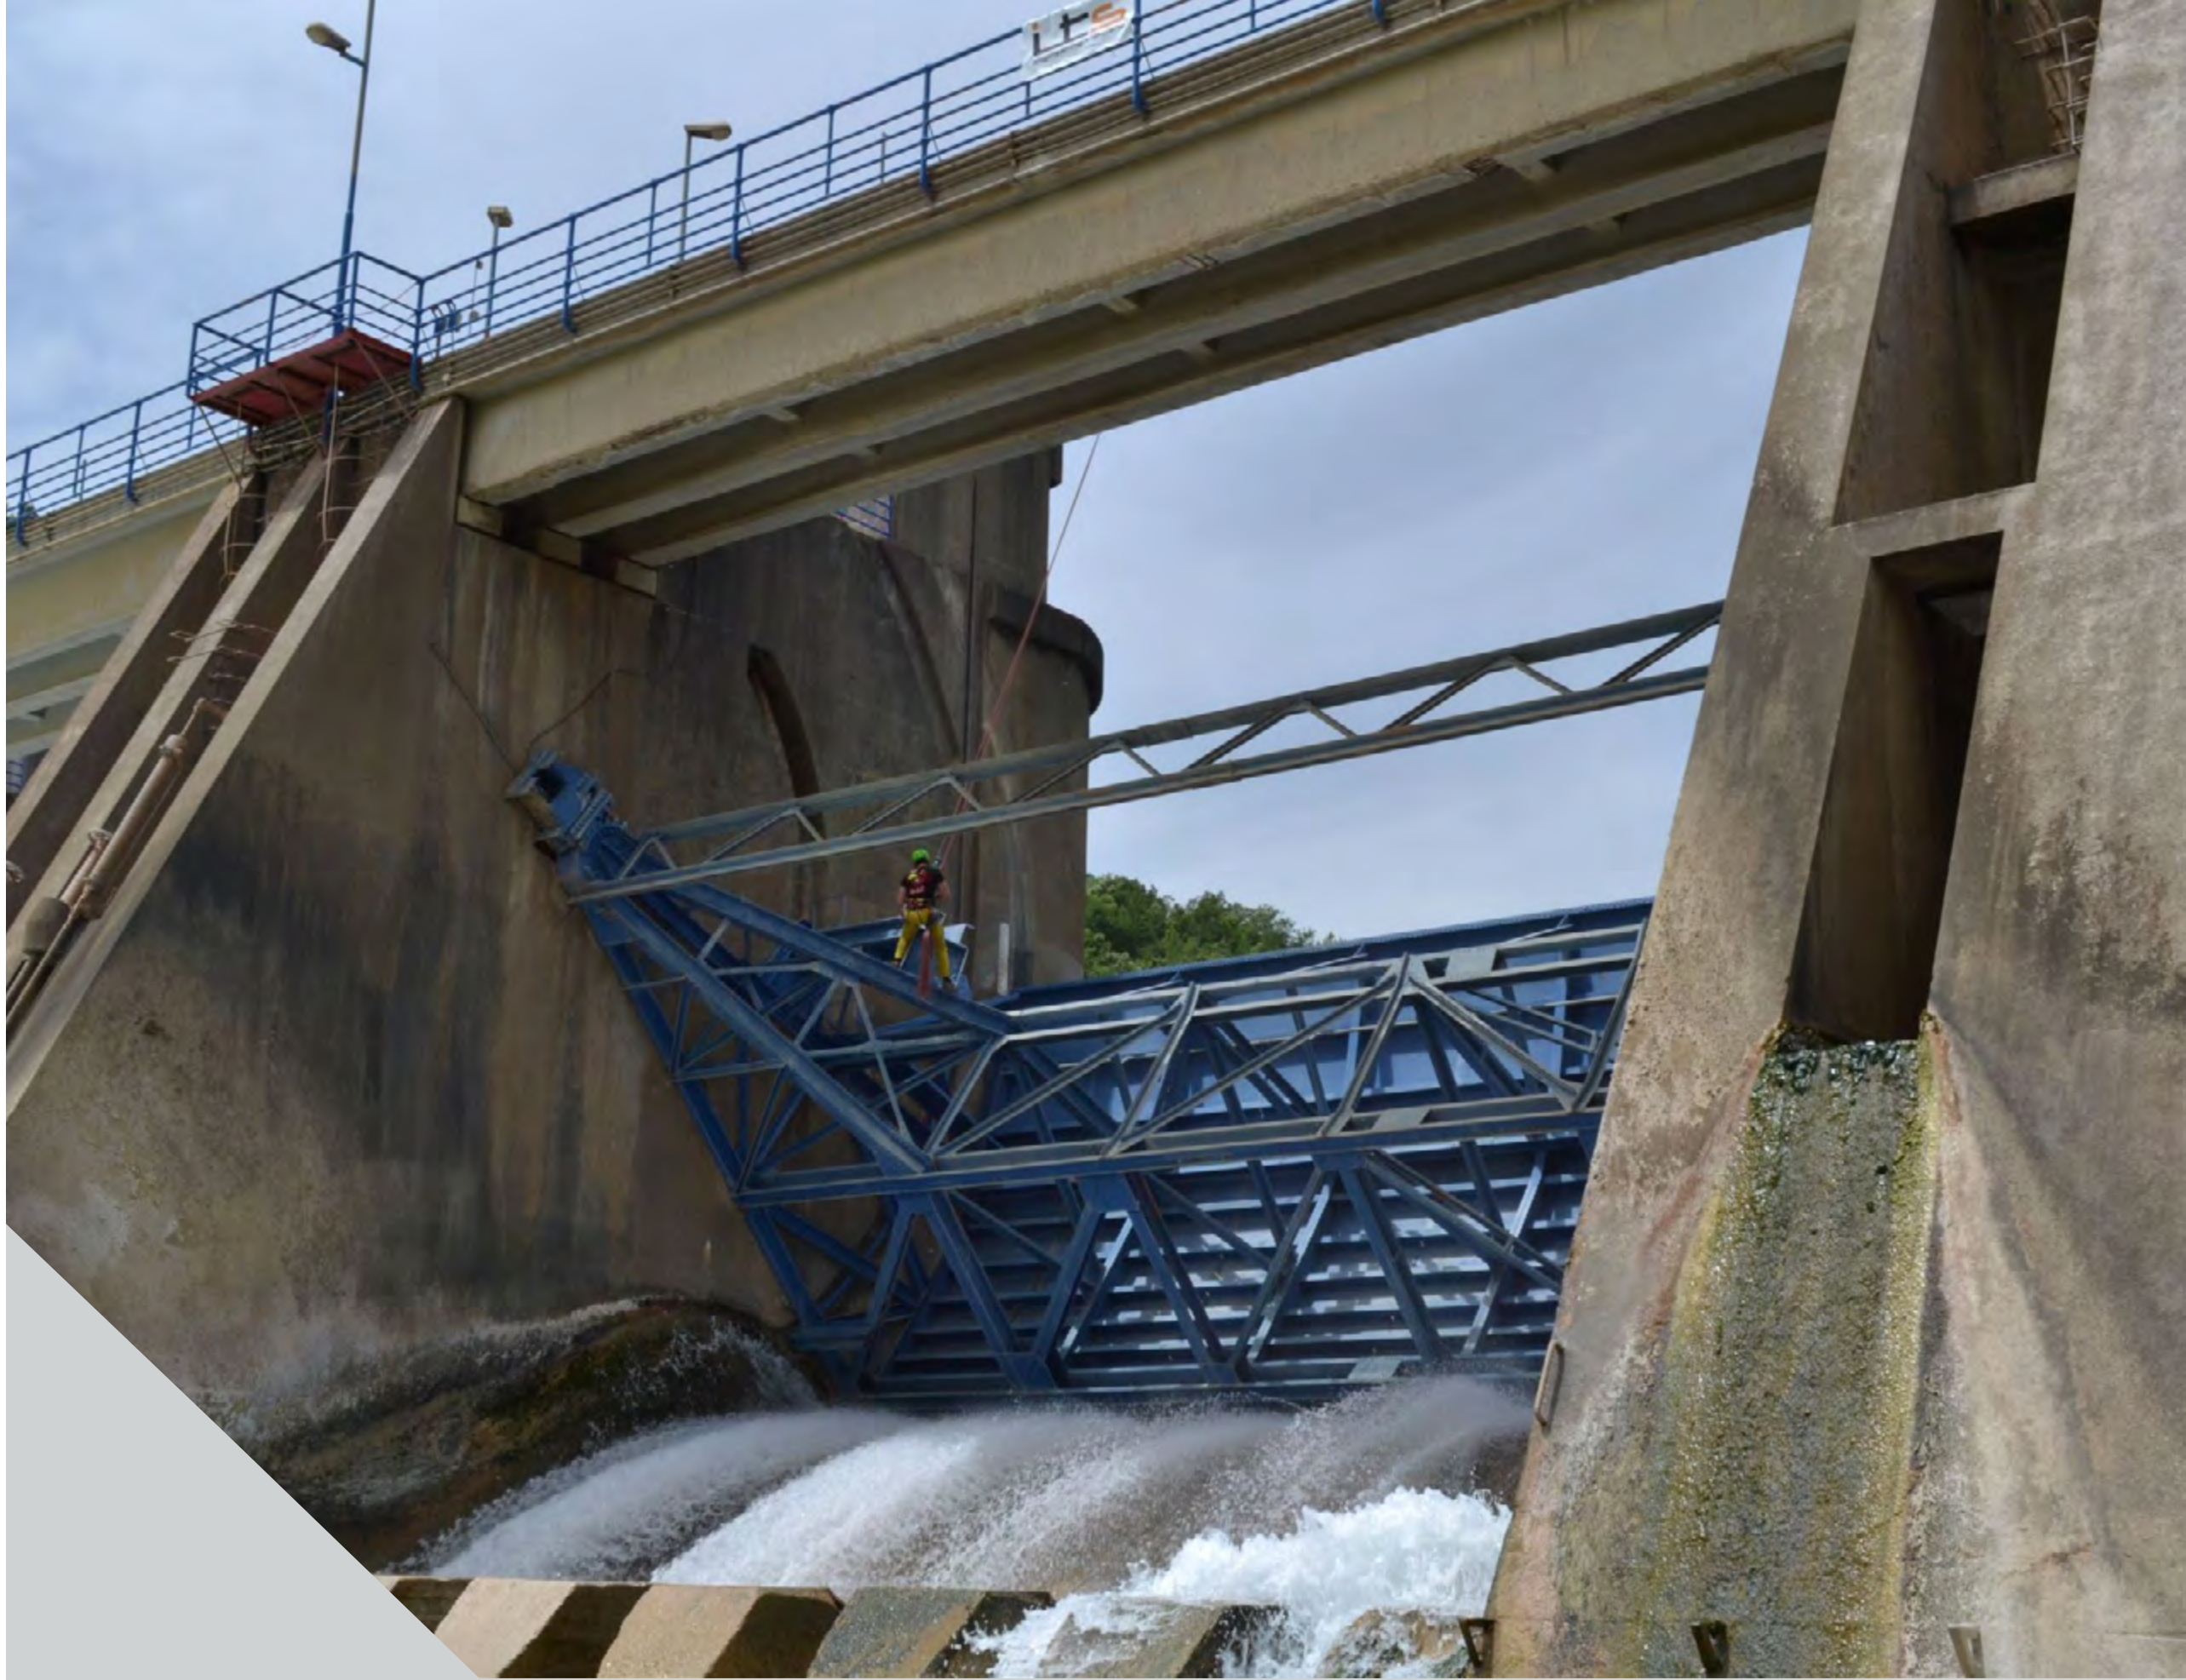
# Persano Dam

## Investigation, seismic vulnerability and monitoring on the Persano crossbar

In the first phase, a historical-critical analysis identified the existing structural system and its state of stress, then we proceeded with the geometric-structural survey to develop an accurate model of calculation of the structure.

Through mechanical characterization of the materials with specific on-site investigations that took place using mountaineering techniques and laboratory tests in order to achieve the most accurate level of knowledge possible, it was arrived at the definition of the actions and related structural analysis with the determination of the vulnerability of the existing structure system.

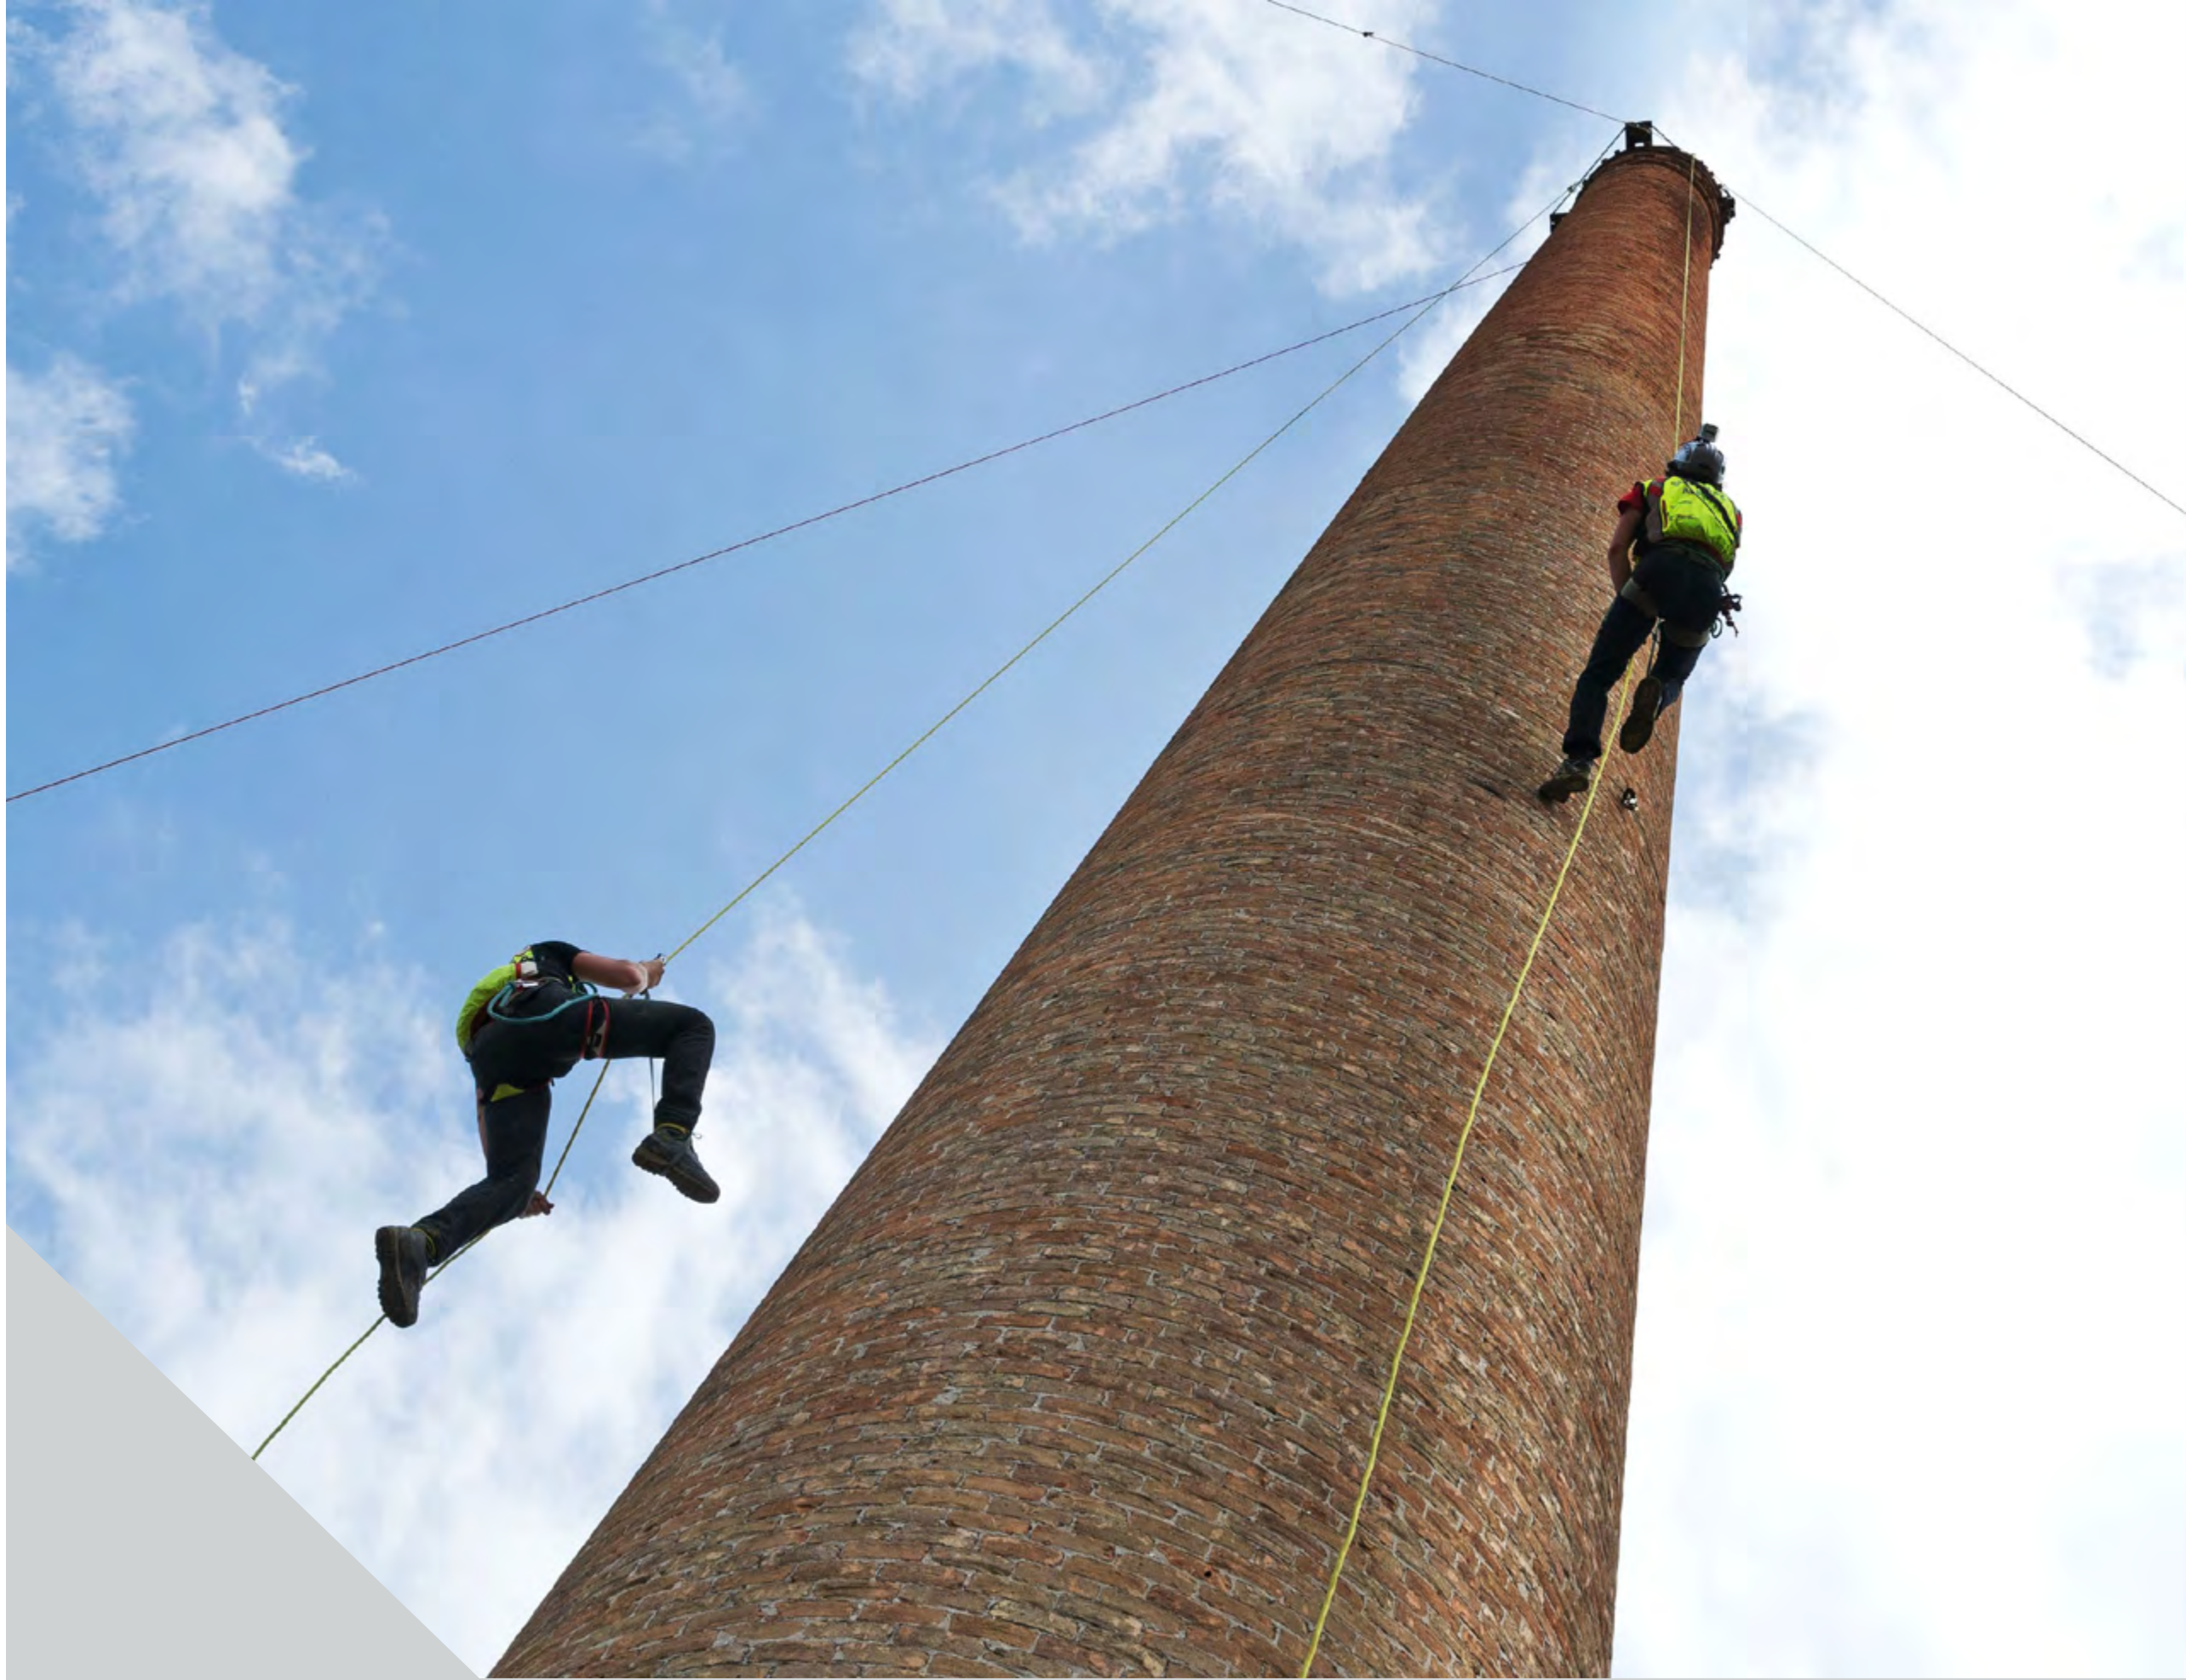
# Chimney of the Former Silk Factory Ancillotto

Renovation and arrangement with seismic adjustment of the former silk factory, re-development of external areas, and structural adaptation of the chimney

The work was aimed at developing the exhibition and service structures used by the company “Santa Lucia Fiere”. The project consists of a renovation and conservation intervention for the reuse of the west pavilion of 6,910.2 cubic meter and the construction of a new 3,740 cubic meter building that functionally connects the two existing pavilions. The scope of the project includes the unbuilt space between the two pavilions, the connecting body to the north, and Via Mareno to the south. The adaptation project (after modeling and dynamic analysis of the structure) aimed to ensure the static and seismic safety of the chimney by intervening with two combined solutions: increasing the load-bearing capacity of the masonry that forms the shaft of the tower and reinforcing the foundation system capable of transmitting the stresses from its own weight and wind to the ground. The increase in the load-bearing capacity of the masonry was possible thanks to a new pre-compression system with high-strength harmonic steel strand cables in two overlapping sets, anchored at the base and tensioned at two different heights along the shaft. The new foundations were made with micro-piles connected at the top and anchored to the existing raft via a network of reinforced concrete beams.
