# INSPECTION DEPARTMENT

Brochure

# The Department

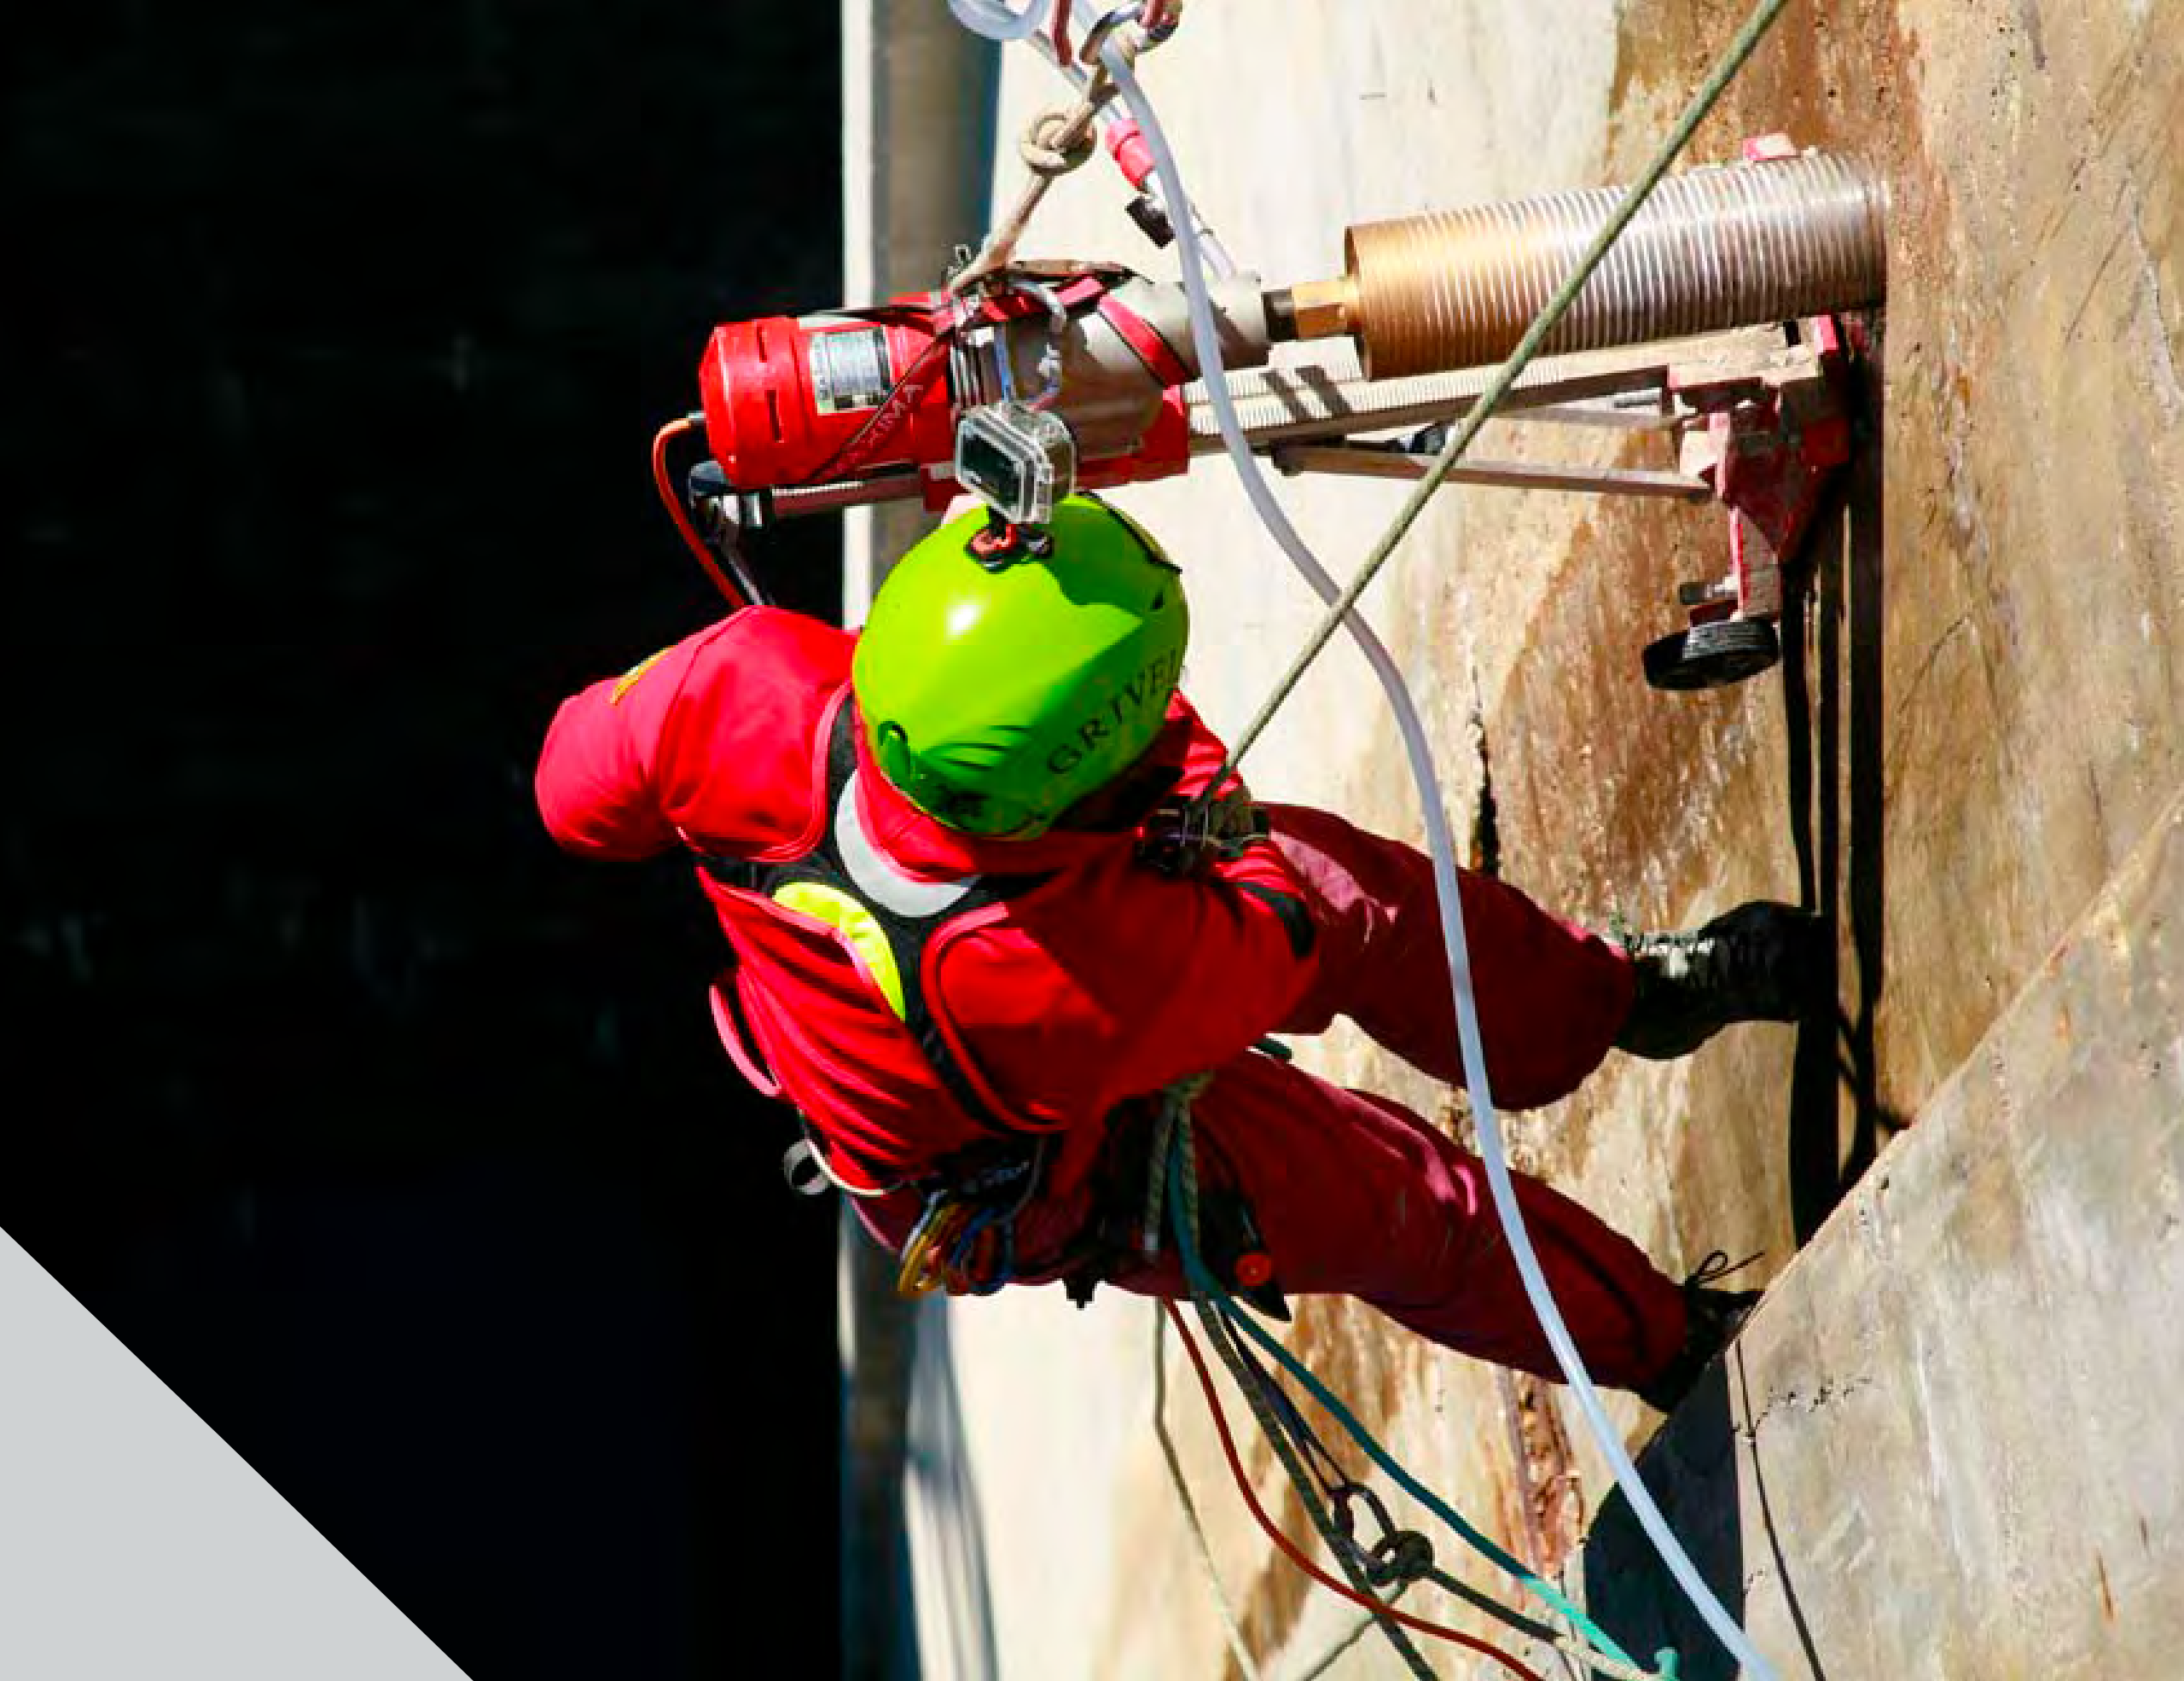
# Cadore Bridge

Structural characterization, new monitoring system and extraordinary maintenance work of the Cadore Bridge on the Piave River

In the first phase the instrumental diagnostic campaign have been planned and the detailed surveys of the entire work (geometry, structural construction details) began. In addition, through the instrumental diagnostic campaign, it was possible to define the properties of the structural materials and the soil of sediments, both through sampling and destructive testing, and through non-destructive checks on the materials. Thereafter, the dynamic characterization of the artifact under ambient vibration conditions was performed to determine the frequencies of the main modes of vibration of the bridge and access viaducts, associated with their modal deforms. A more detailed bridge model was developed, by which the Non-Linear Dynamic analysis was conducted.
